# Pre-drywall inspection

ILLUSTRATIVE SAMPLE REPORT

| <b>Inspection</b> | October 2, 2026 PD-2026-014 |
| <b>Property</b> | Two stories Approx. 2,500 sq. ft. Slab foundation |

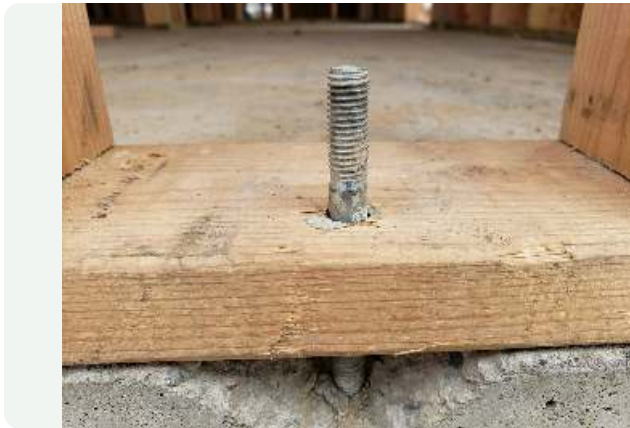
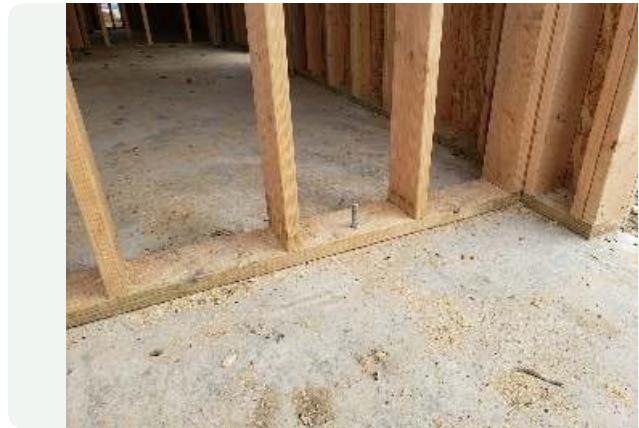
# 01 Anchor connections incomplete

Nuts and washers are missing from the visible wall-plate anchor connections at the locations pictured.

These connections do not clamp the wall plate as intended until the required hardware is installed.

Garage - connection detail

Garage - same connection, wider view

Have the builder complete the connections using the approved foundation and framing details. Verify the hardware and connections before they are concealed.

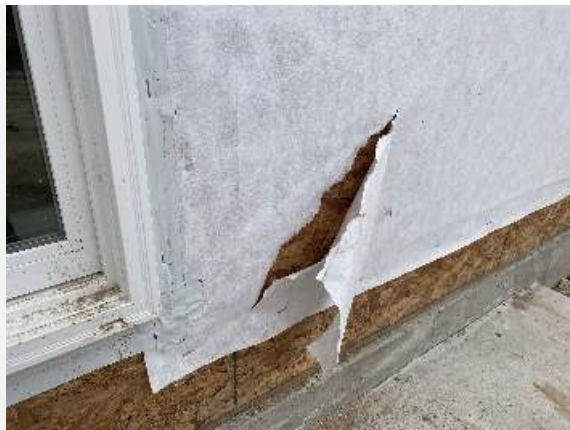
Back of house

## 02 Weather barrier torn

The exterior weather barrier has tears that expose the wall sheathing at the pictured locations.

Openings interrupt the protective layer that helps direct water away from the wall assembly.

Have the builder repair the tears with compatible materials and methods specified by the installed weather-barrier manufacturer before exterior finishes cover these areas.

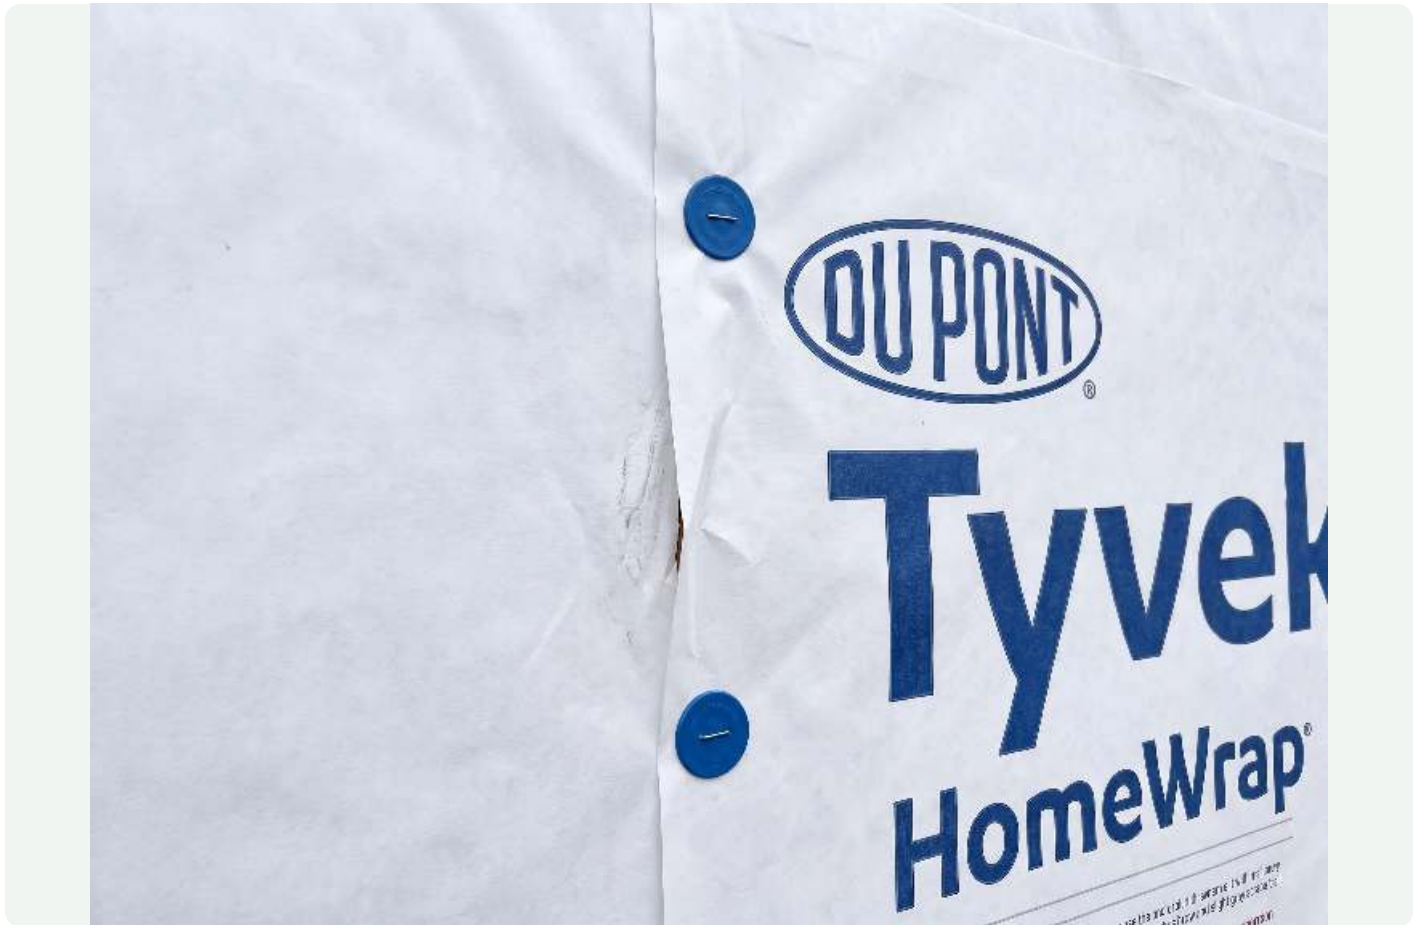
Right side of house

## 03 Weather-barrier seam left unsealed

The pictured vertical weather-barrier overlap is unsealed. Localized damage is also visible along the edge.

An open or damaged seam can interrupt the intended continuity of the water and air control layer.

Have the builder verify the seam detail required for the installed product, seal the overlap as required, and repair the damaged edge with compatible materials before cladding.

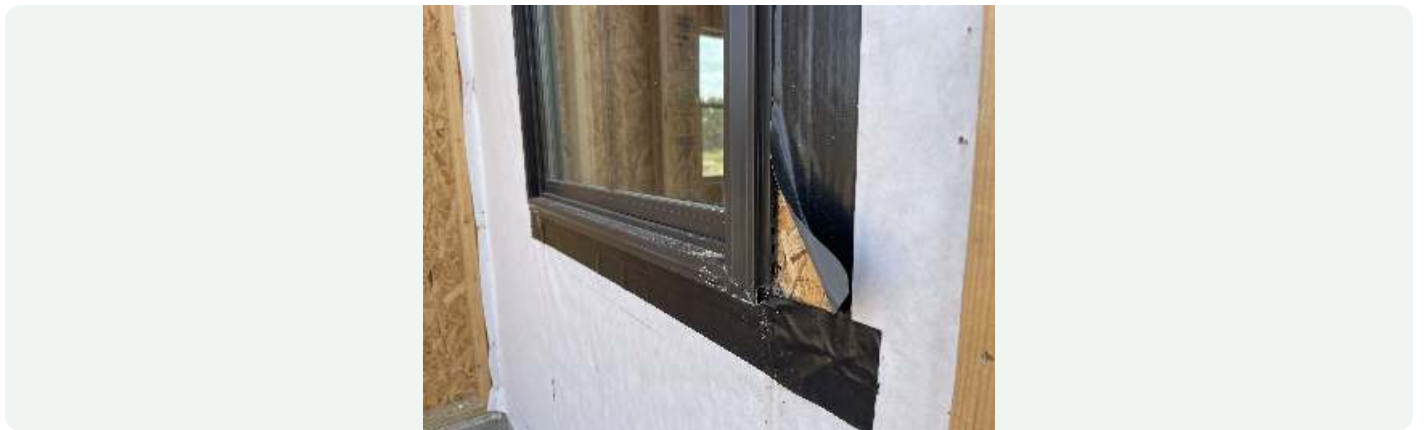
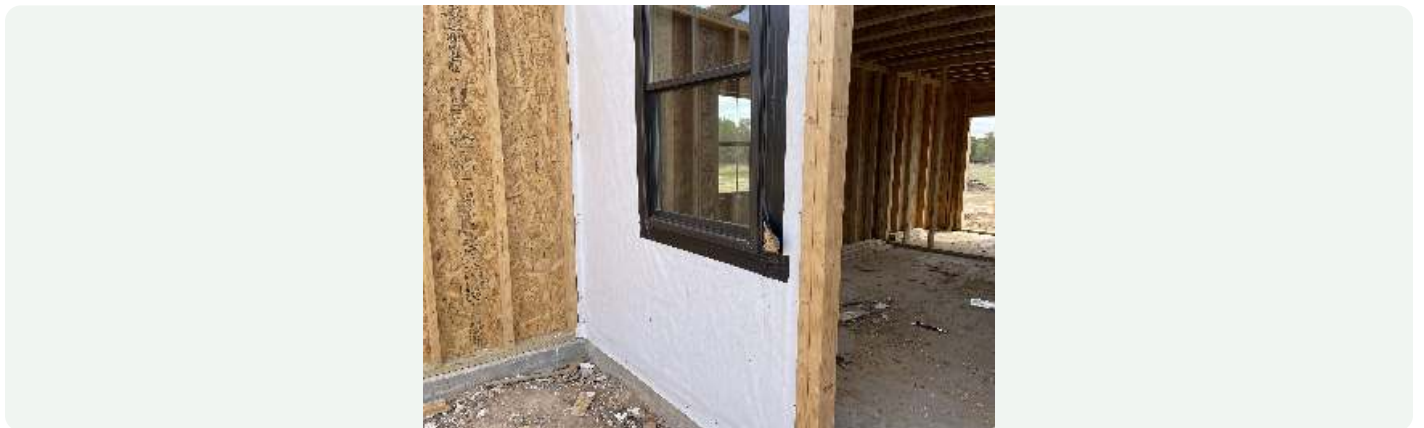
## 04 Window flashing not fully adhered

The flashing tape is lifted away from the sheathing at the pictured window corner.

Water may enter behind lifted flashing instead of draining to the outside of the wall.

Front bedroom window - detail

Front bedroom window - wider view

Have the window installer or builder restore flashing adhesion and continuity using the window and flashing manufacturers' installation instructions. Complete the repair before the area is covered.

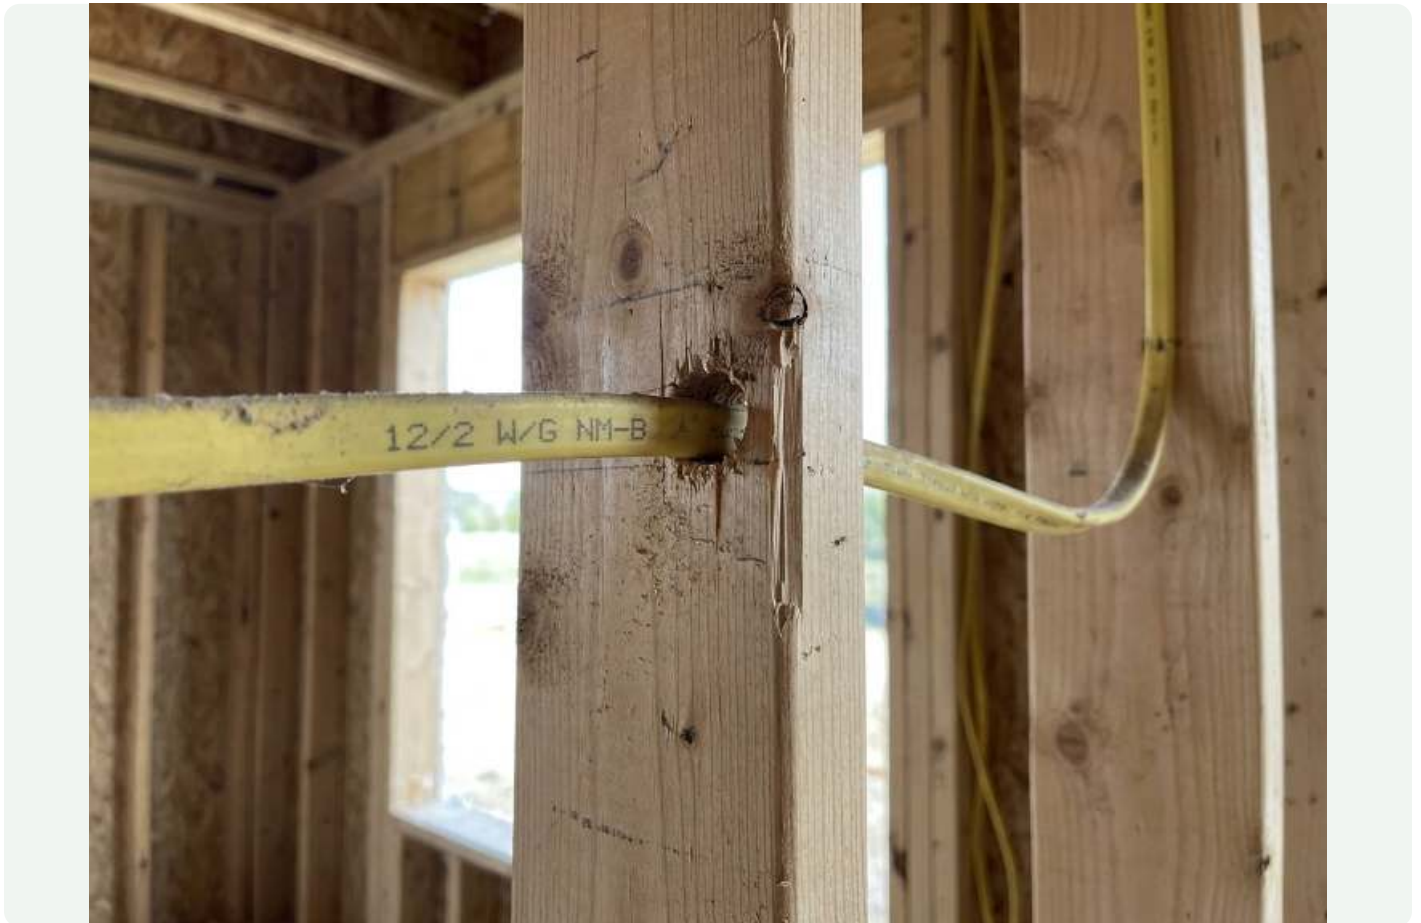
Kitchen

## 05 Cable protection missing at stud

The pictured electrical cable passes through a stud close to the face where wall finishes will be attached. A protective steel plate is not present.

Drywall screws, nails, or later wall attachments could damage wiring that is too close to this face.

Have a qualified electrician verify the cable setback and install suitable protective plates where required before drywall installation. The photo does not establish an exact measured setback.

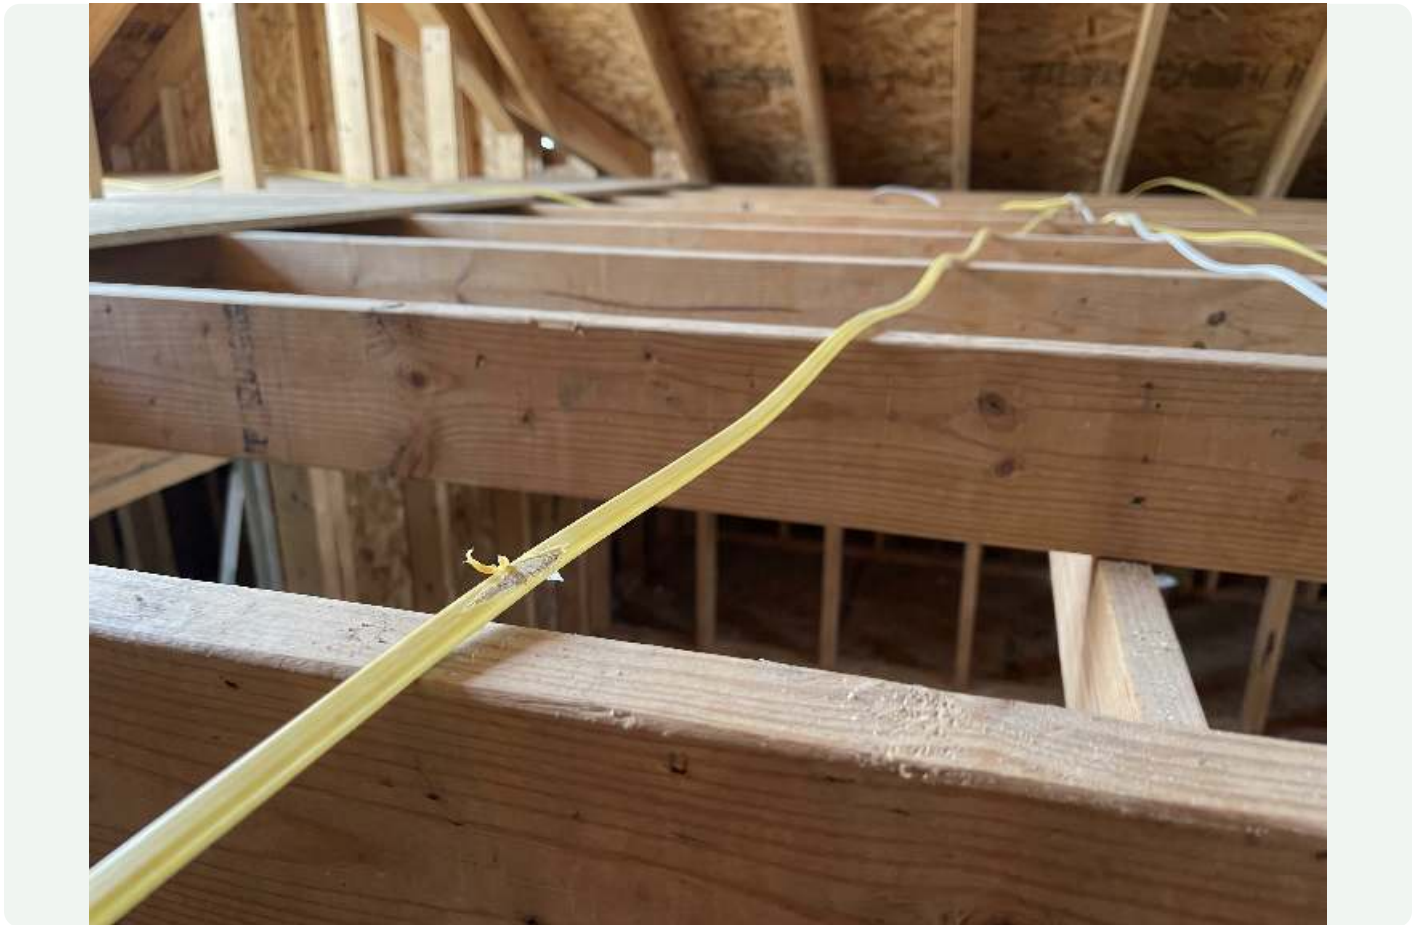
Attic

## 06 Cable jacket damaged

The yellow outer jacket of the pictured cable is scraped and torn where it crosses the ceiling framing.

The jacket protects the wiring. The visible damage warrants evaluation; a photograph cannot establish the condition of the insulation or conductors beneath it.

Have a qualified electrician examine the affected cable and replace damaged wiring as needed before concealment. Surface tape alone should not be assumed to resolve the condition.

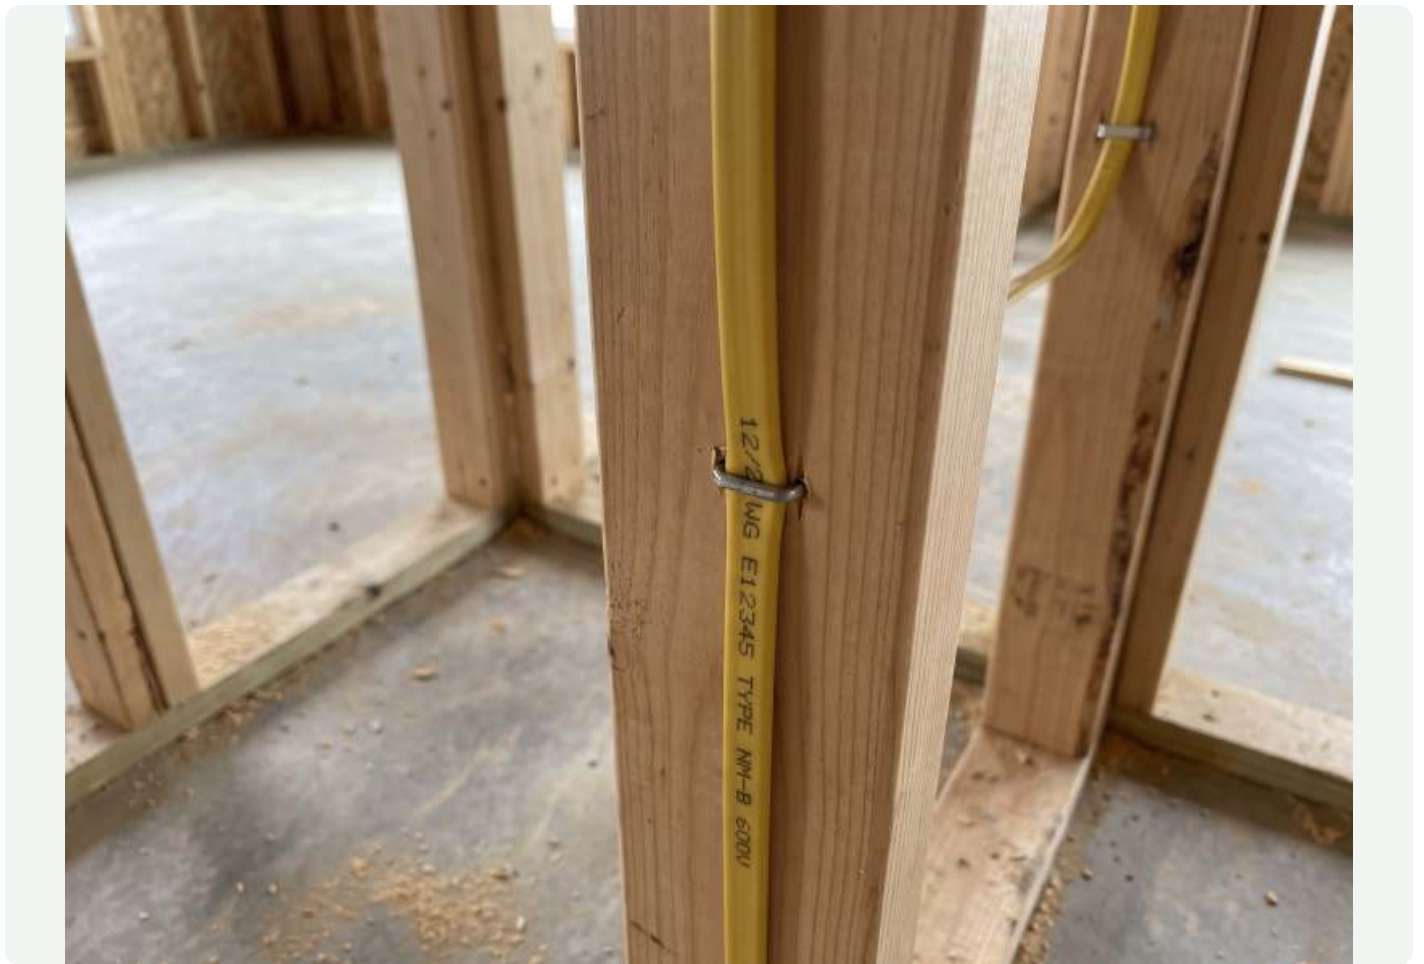
Upstairs bedroom

## 07 Staple compressing cable

The pictured staple is tightly driven and visibly indents the cable jacket.

Overtight fastening can damage the cable jacket or the insulation beneath it.

Have a qualified electrician correct the fastening and examine the affected cable. Replace damaged wiring as needed before drywall installation.

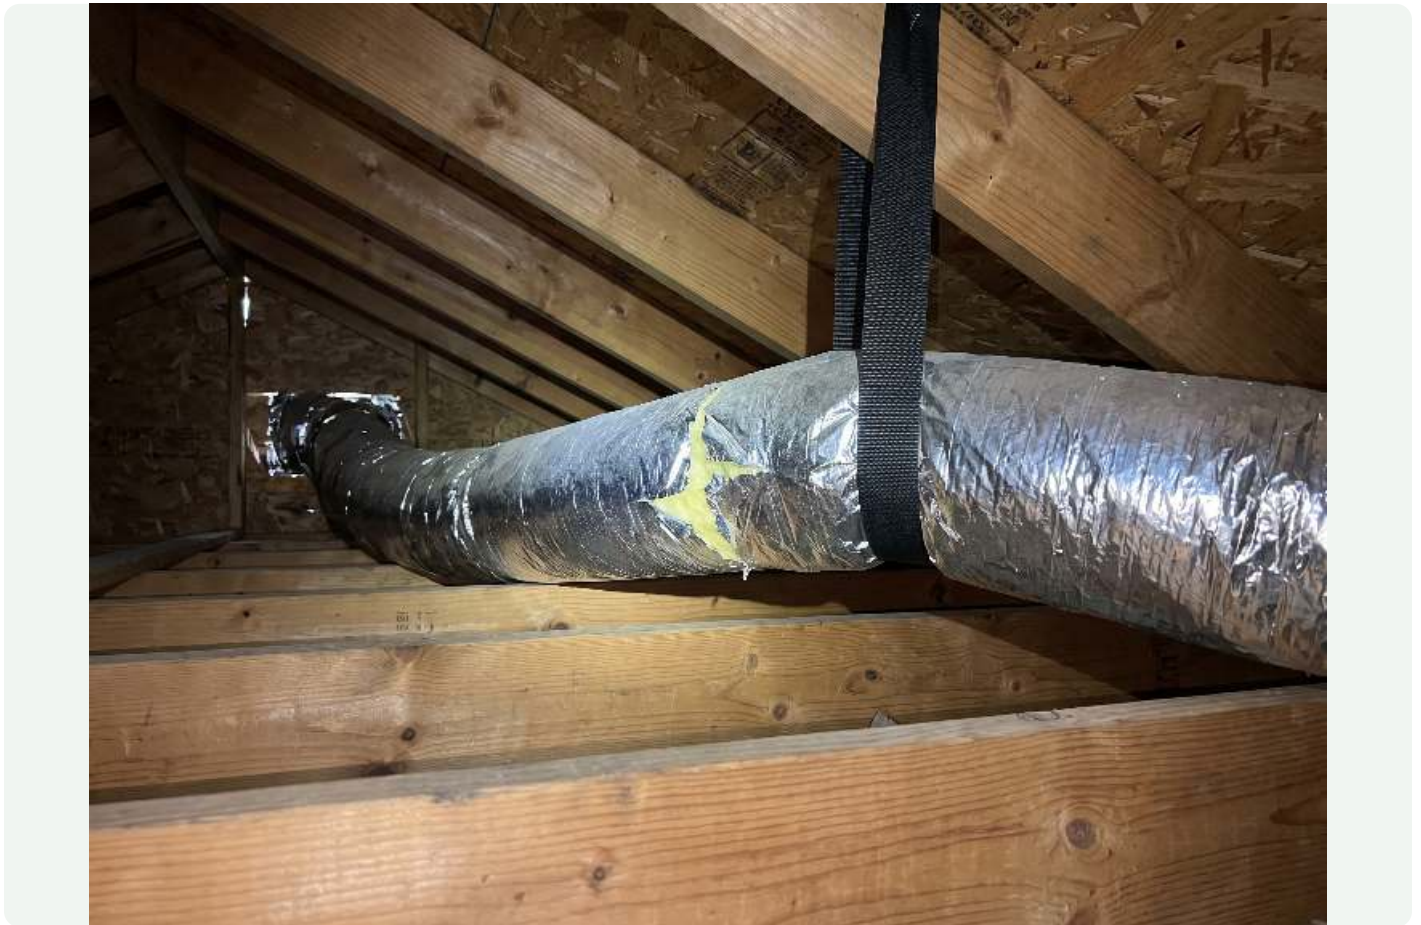
Attic

## 08 Flexible-duct outer jacket torn

The outer jacket of the pictured flexible duct is torn, exposing the fiberglass insulation.

The opening can allow moisture into the insulation and reduce its protection. The inner duct core is not visible through the entire damaged area.

Have the HVAC contractor repair the jacket and restore the insulation using the duct manufacturer's approved method. Inspect the underlying core and repair or replace the duct if it is damaged.

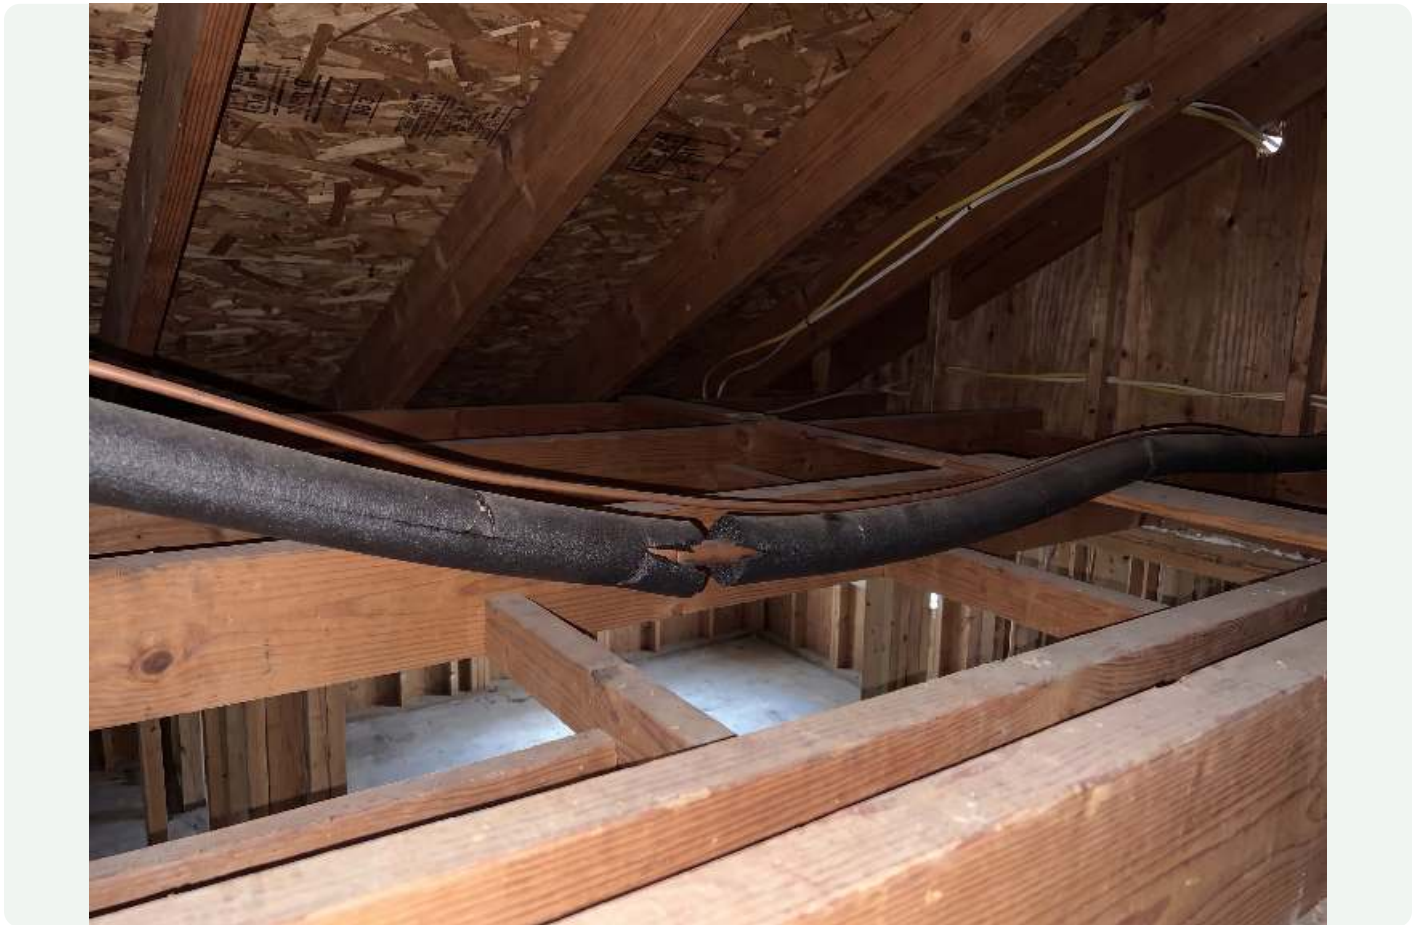
Attic

## 09 Refrigerant-line insulation open

A torn section of insulation leaves part of the pictured refrigerant line exposed.

An exposed cold line can collect condensation and gain heat. Condensation may wet nearby building materials.

Have the HVAC contractor restore continuous insulation on the affected line and seal the joints using suitable materials and the insulation manufacturer's instructions.

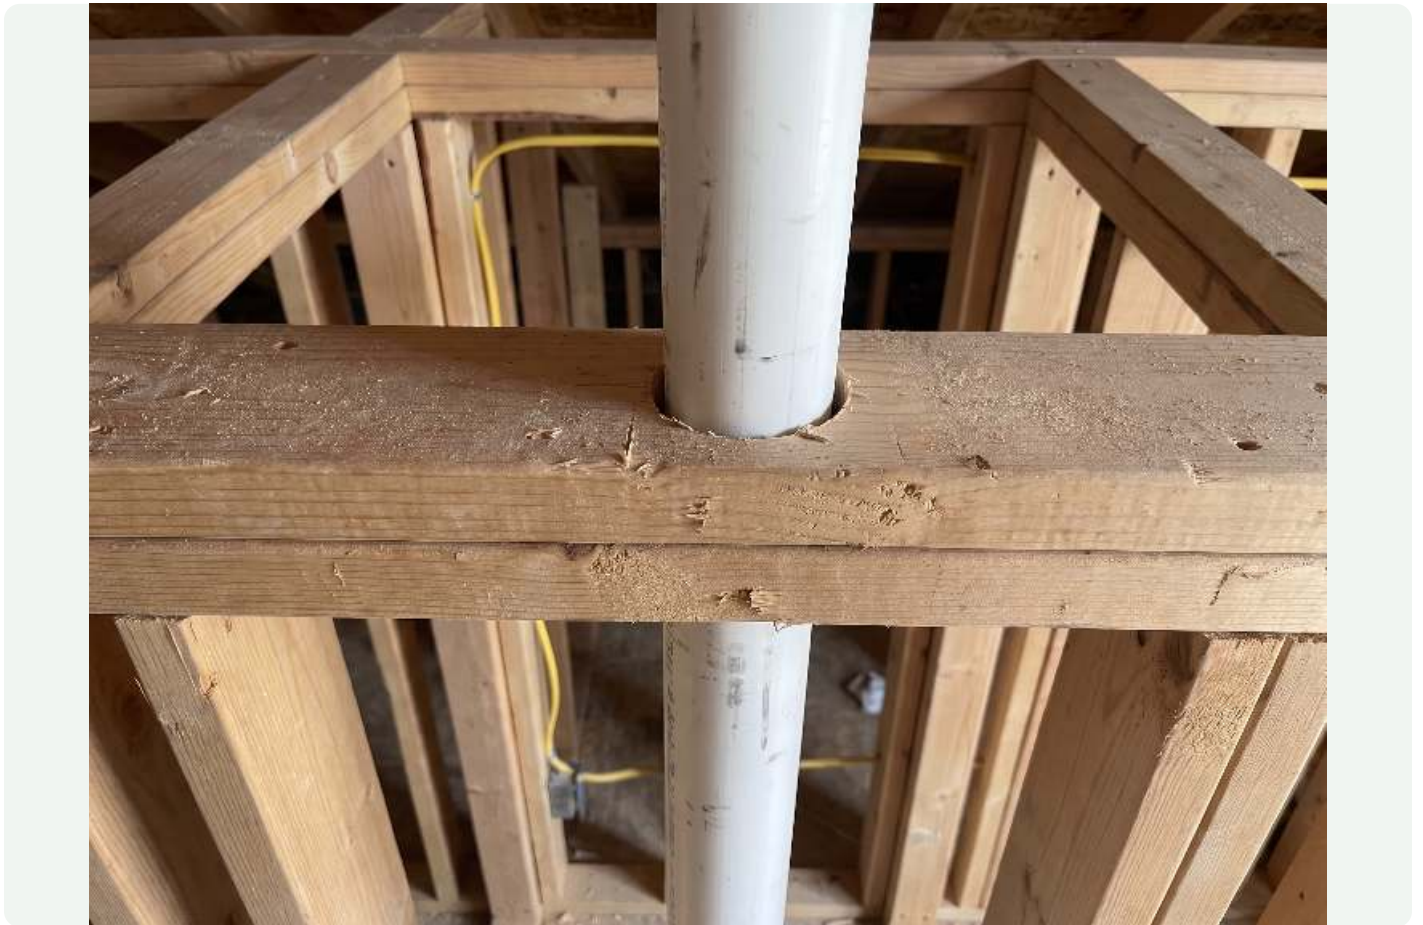
**Upstairs bathroom**

## 10 Gap around pipe penetration

An open gap remains around the plumbing pipe where it passes through the wall top plates at the pictured location.

This opening can provide a path for smoke and flame between the wall cavity and the space above.

Have the builder or responsible trade close the opening with approved fireblocking material suitable for the pipe and gap before concealment. Do not assume ordinary foam is an approved substitute.
