TREC 7-6 RESIDENTIAL INSPECTION

146 Gold Rush Dr
Cedar Park, TX 78613

PROPERTY INSPECTION REPORT FORM

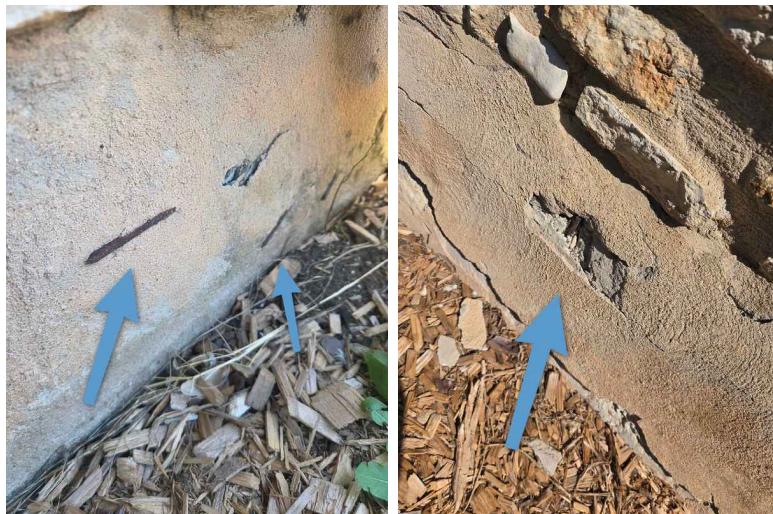
1: Concrete foundation walls: deterioration, minor, exterior

Portions of the concrete foundation wall surfaces exposed to weather exhibited minor deterioration.

Recommend qualified contractor to seal and patch to prevent further damage from moisture intrusion.

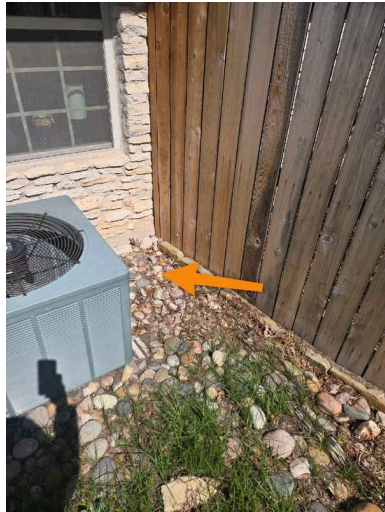
The home had areas of neutral or negative drainage that will route runoff from precipitation toward the foundation. To help reduce the risk of foundation damage, the ground should slope away from the home a minimum of 1/4-inch per foot for a distance of at least six feet from the foundation.

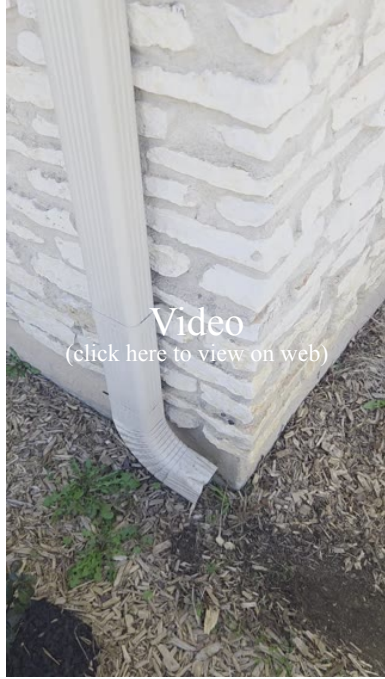
2: Roof drainage: downspouts, discharge to foundation

One or more downspouts discharged roof drainage next to the foundation. This condition can result in high moisture levels in soil at the foundation that can cause damage related to soil/foundation movement. Downspout extensions should be installed to discharge roof drainage away from the foundation.

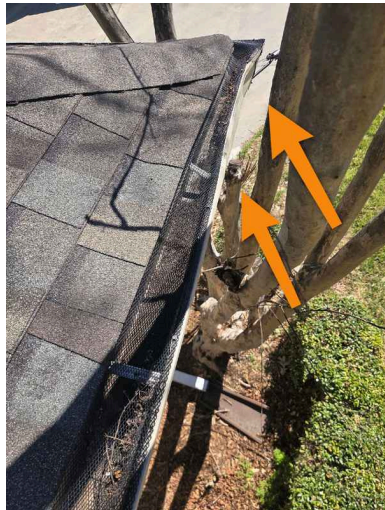
3: Roof drainage: gutters bent / damaged

The gutters were bent or damaged. This condition can result in excessively high moisture levels in soil near the foundation that can cause damage related to soil/foundation movement. Damaged gutter sections should be replaced by a qualified contractor.

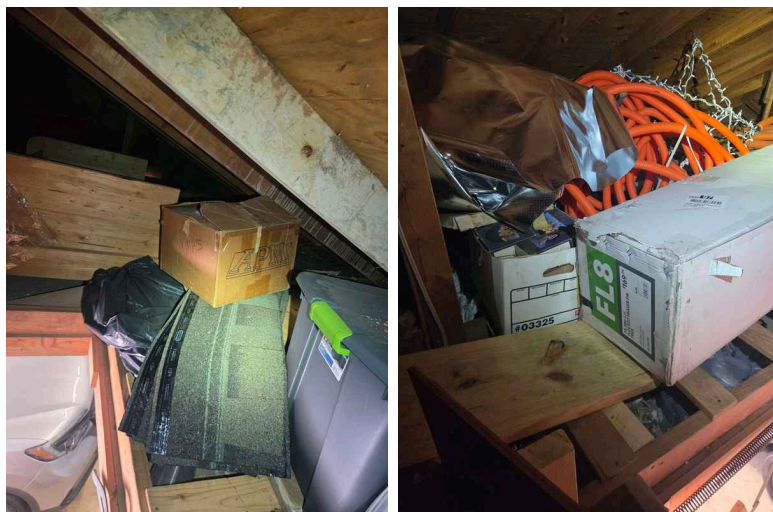
Attic access: attic storage limited access:

The occupant's belongings were stored in the attic and blocked access to and view of portions of the attic. Because attics may contain potential fire or health hazards, other safety or mechanical issues, or damage, the attic should be inspected by a qualified inspector after access to the entire attic is provided. The inspection company disclaims responsibility for identifying any deficiencies that were not readily visible during inspection.

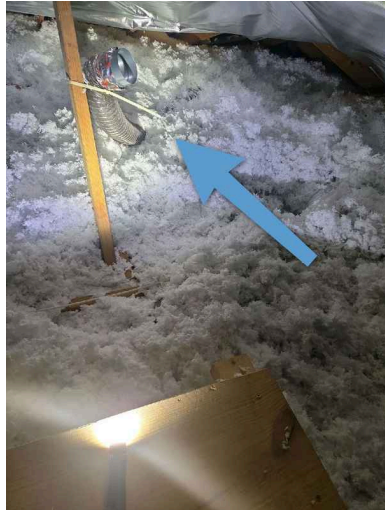
1: Attic ventilation: bathroom fan duct terminates in attic

A bathroom exhaust vent terminated in the attic instead of at the home exterior. This condition can raise moisture vapor levels in the attic to the point at which home materials are damaged or unhealthy conditions related to mold develop. This installation may have been acceptable at the time of original construction. No problems that appeared to be related to this condition were observed however this should be corrected to prevent moisture build up in the attic.

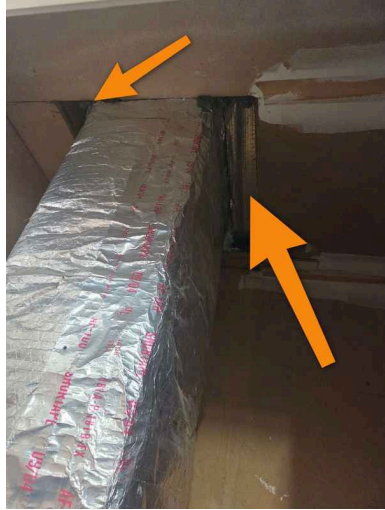
The garage ceiling had holes at the time of the inspection. These holes should be repaired to provide an intact fire-resistant barrier between the garage and the adjoining living space.

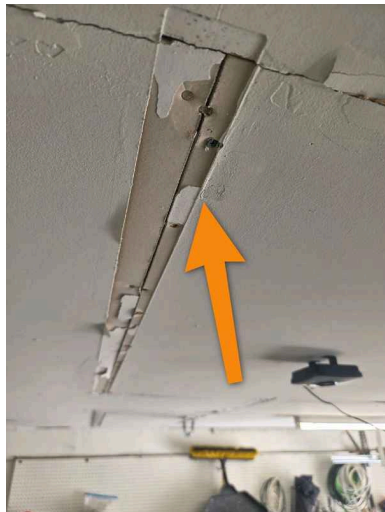
3: Fire separation: ceiling, no fire-taping

Garage ceilings were drywalled, but not fire-taped. Modern building practices require that fire-taped drywall be installed on any ceiling adjoining living space for safety reasons. The Inspector recommends drywall be fire-taped to comply with modern safety requirements related to safety hazards.

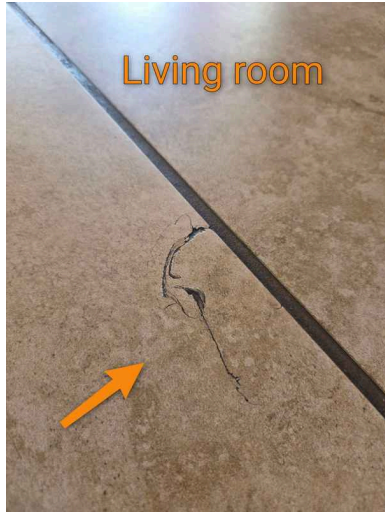
4: Floor tile: cracked

Floor tiles were cracked. You should ask the seller if spare tiles are available as matching replacements. You should consult with a qualified contractor to discuss options and costs for replacement.

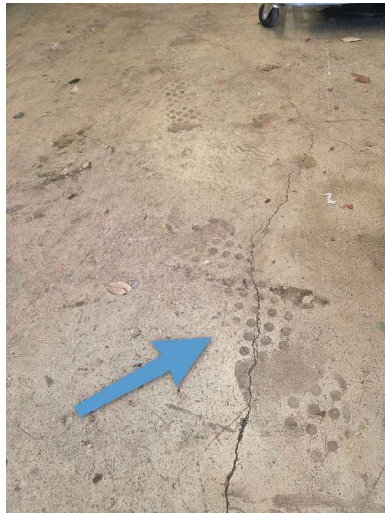
5: Garage floor: cracks, shrinkage, OK

The garage floor had common shrinkage cracks. These cracks are not a structural concern.

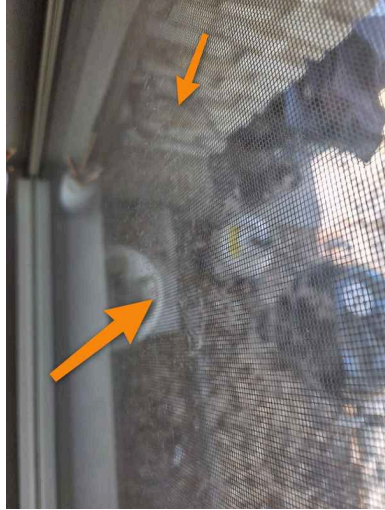
Condensation visible in the double-pane glazing of some windows indicated a loss of thermal integrity. You should consult with a qualified contractor to discuss the need, options, and costs for repair or replacement.

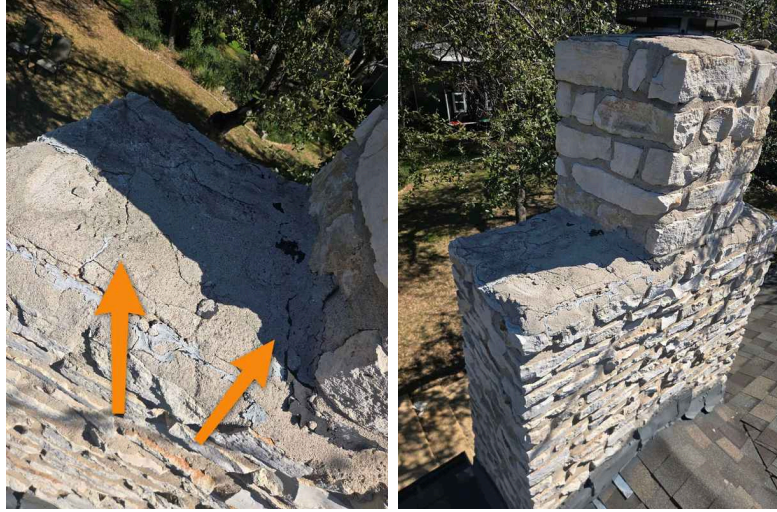
1: Chimney crown: cracking, moderate

Moderate cracking visible in the chimney crown should be filled with an appropriate sealant by a qualified masonry contractor to prevent worsening damage caused by moisture in the cracks expanding as it freezes.

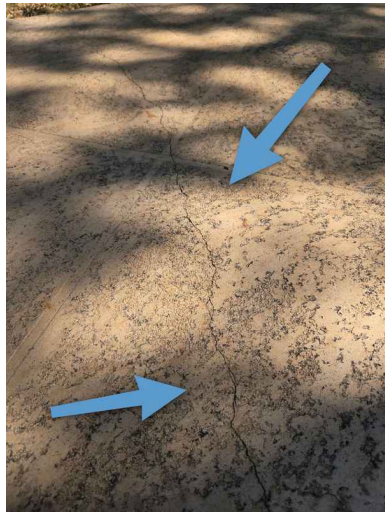
1: Patio concrete slab: shrinkage cracks

The concrete patio slab had shrinkage cracks visible. Shrinkage cracks are common surface cracks and are not a structural concern.

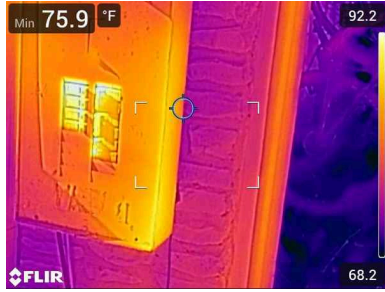
Normal temperature range observed at the time of the inspection

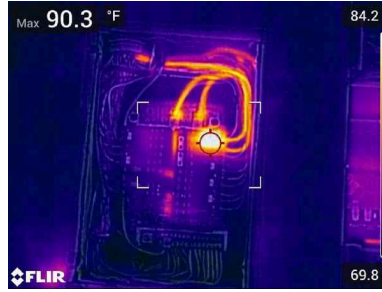
Normal temperature range observed at the time of the inspection

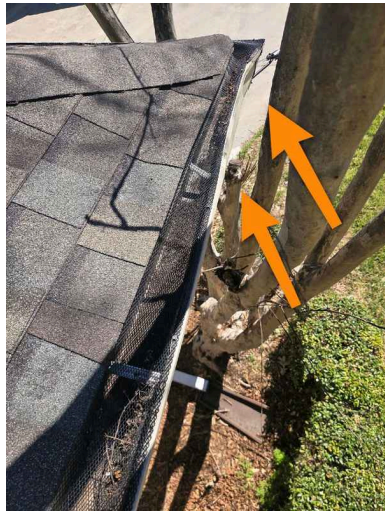
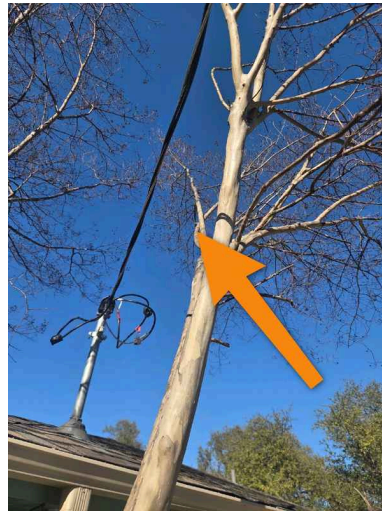
1: Service drop: clearance from trees- monitor

The overhead electrical service conductors were routed near tree branches. Although this did not appear to be a problem at the time of the inspection, as tree branches grow they may begin to contact and abrade the service conductors during windy periods.

To avoid conductor damage from abrasion, you should monitor this condition and arrange to have tree branches cut back as necessary. Work around the service conductors should be performed by a qualified personnel only.

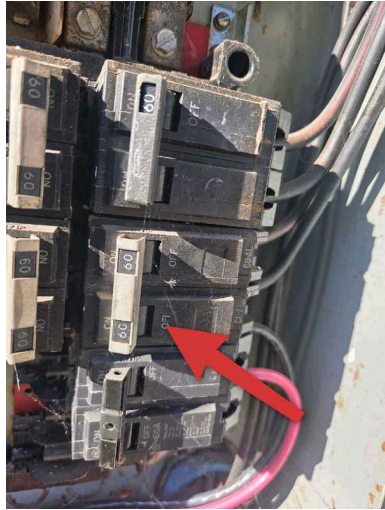
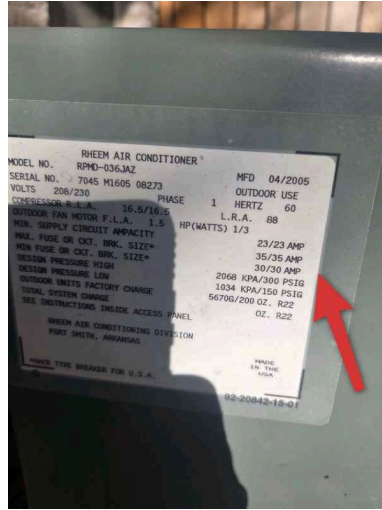
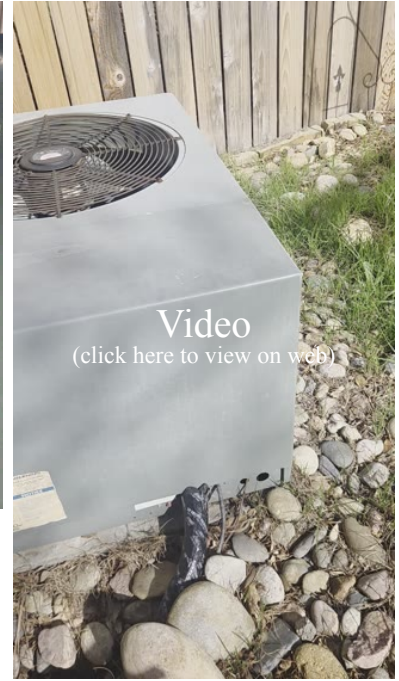
Breakers of excessive amperage (60 amps when 35 amps is called out on the air conditioning condenser label) were installed the electrical service panel. This condition is a potential fire hazard. The Inspector recommends immediate correction by a qualified electrical contractor.

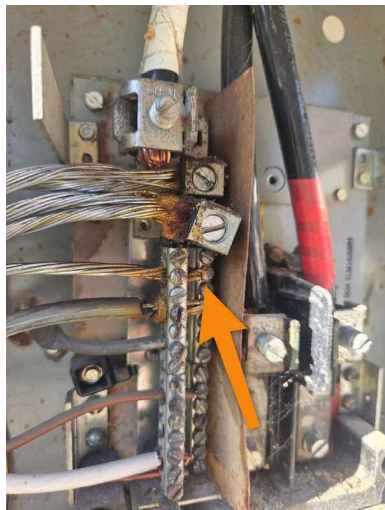
4: Service panel: interior, corrosion

The interior of the electrical service panel cabinet exhibited moderate amounts of corrosion indicating some moisture intrusion. Corrosion can degrade electrical connections, a potential fire hazard. The panel should be serviced by a qualified electrical contractor.

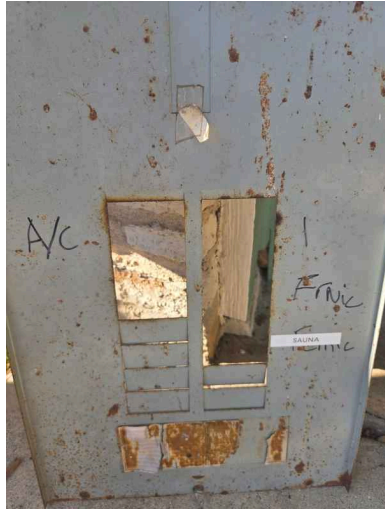
5: Service panel: label, circuit directory, missing

The electrical service panel circuit directory label was missing. A properly-marked circuit directory should be installed by a qualified electrical contractor so that individual circuits can be quickly identified and shut off during an emergency.

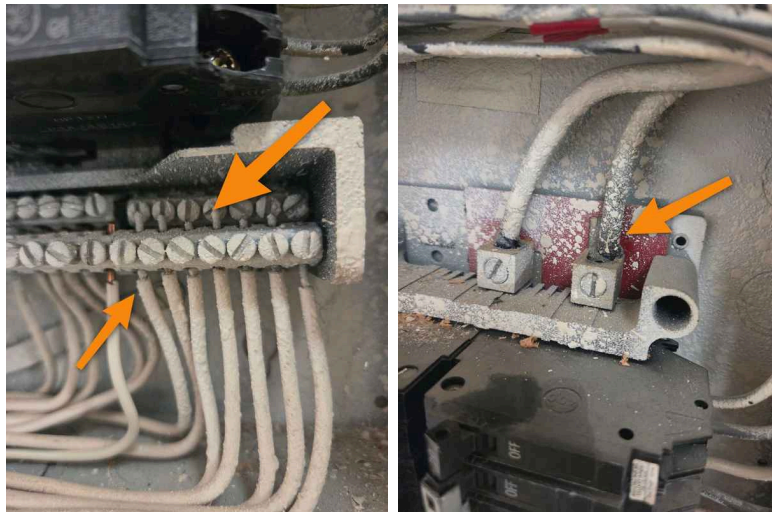
6: Sub-panel: interior, paint overspray

The interior of this electrical sub-panel was contaminated with paint overspray. This condition can deteriorate electrical connections, a potential fire hazard. The panel interior should be cleaned by a qualified electrical contractor.

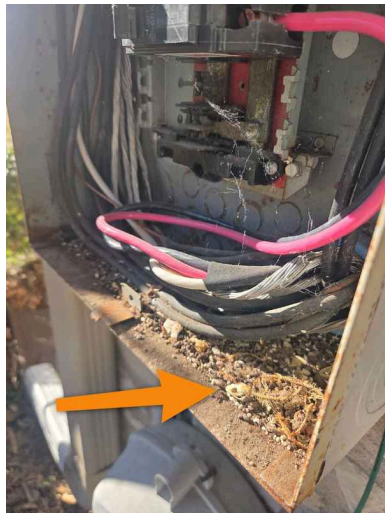
7: Debris in the main panel, recommend qualified electrician to correct

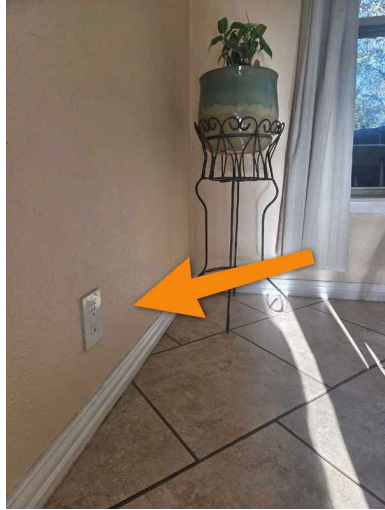
2: Receptacle: loose

An electrical receptacle was loose and moved when a plug were inserted, a potential fire/electrical shock hazard. Correction should be made as necessary by a qualified electrical contractor.

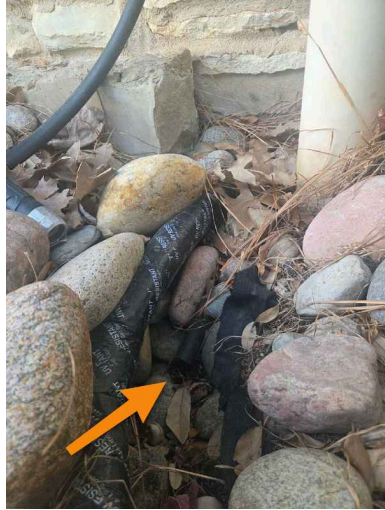
The condensate disposal tube discharge too low to the ground. This condition may result in tube blockage that will shut down the air-conditioning system until the blockage is cleared.

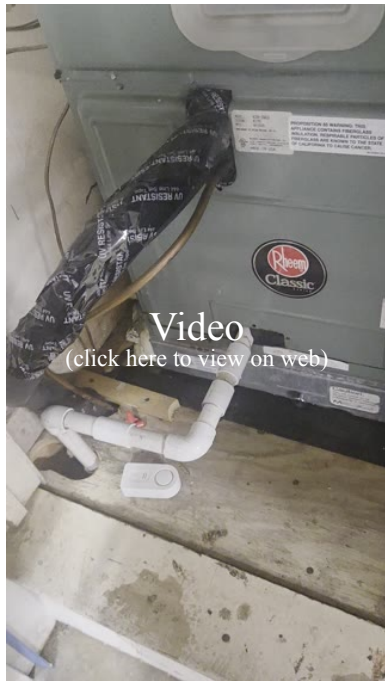
2: AC condensate disposal: no overflow pan

The attic-installed cooling system evaporator coils had no secondary condensate drain pan installed. If the primary condensate drainage system should fail, this condition could result in moisture damage to attic or home materials. A secondary drainage system such as a pan with an overflow routed to discharge properly should be installed by a qualified HVAC contractor.

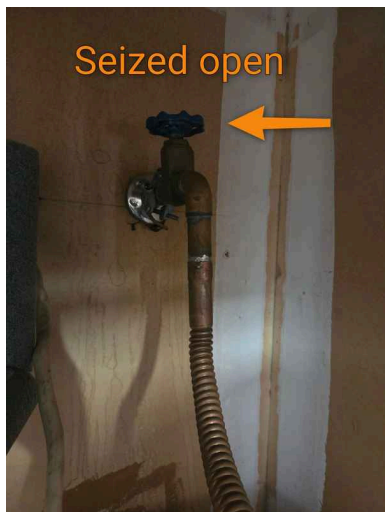
No operable cold water shut-off was installed at the water heater. This condition will complicate service. A shut-off should be installed by a qualified plumbing contractor.

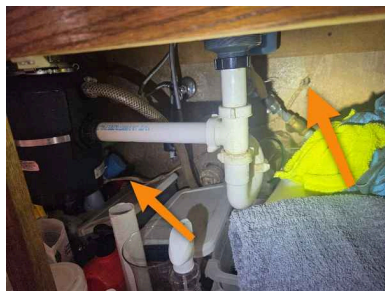
1: Electrical connection improper

The electrical connection to the garbage disposal was missing protective bushings at the disposal motor and should not pass through a open hole at the back of the cabinet. This is a risk for mechanical damage to the wiring and electrical shock hazard. The disposal should either be powered by an approved appliance cord plugged into a dedicated outlet, or be wired directly to a 20-amp gfci overcurrent protection device. This condition should be corrected by a qualified electrician.
