# AUSTIN REAL ESTATE INSPECTIONS (SPA)

## TREC 7-6 RESIDENTIAL INSPECTION

1234 Main Street  
Cedar Park TX 78613

08/29/2026 9:00AM

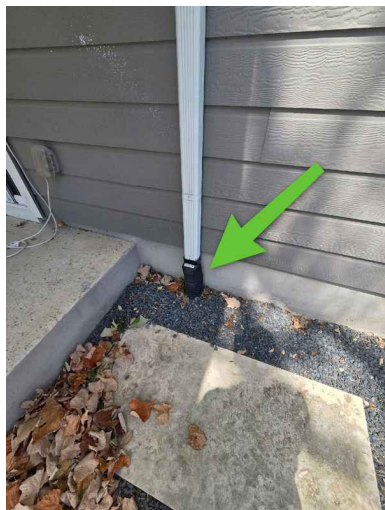
Exterior left

*Subsurface Gutter Extension Incomplete:* A subsurface gutter extension enters the ground but its discharge end cannot be located. The extension should be traced to verify it terminates properly and remains clear to function as designed for effective drainage away from the foundation.

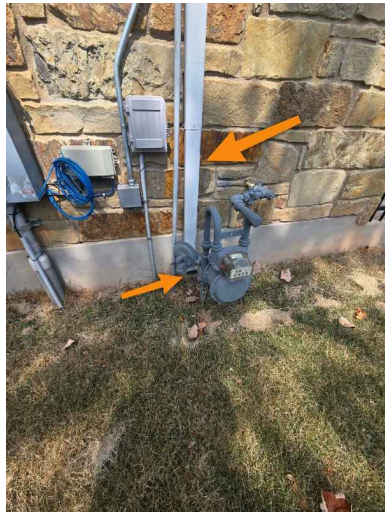
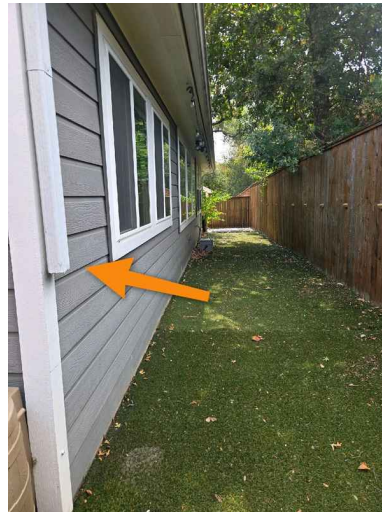
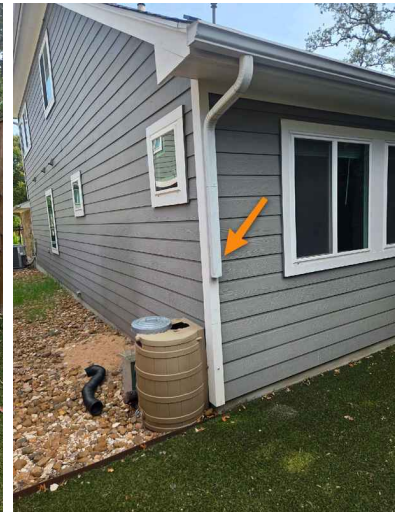
## 2: Roof drainage: downspouts, discharge to foundation

One or more downspouts discharged roof drainage next to the foundation. This condition can result in high moisture levels in soil at the foundation that can cause damage related to soil/foundation movement. Downspout extensions should be installed to discharge roof drainage away from the foundation.

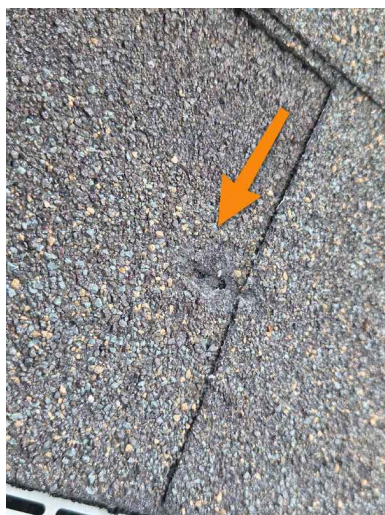
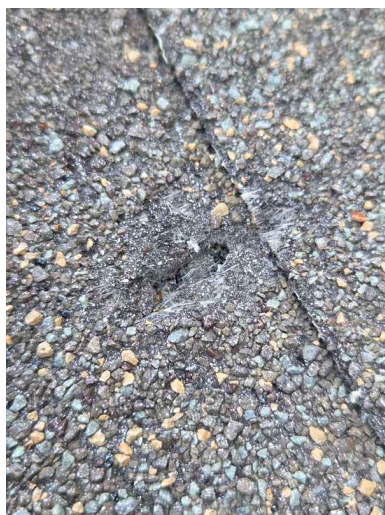
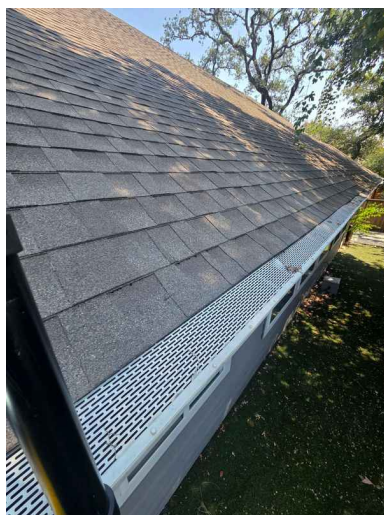
**1: Asphalt shingles: deterioration, moderate**

Moderate deterioration and localized damage were observed at the asphalt shingles. Have a qualified roofing contractor evaluate and repair damaged areas as needed

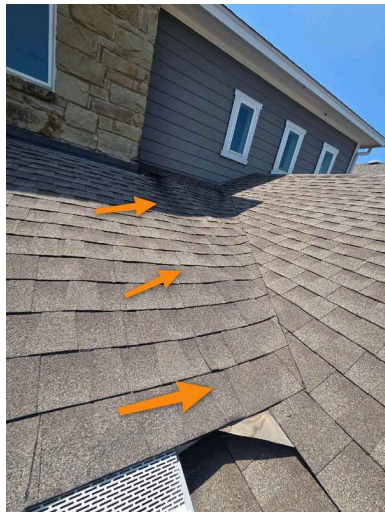
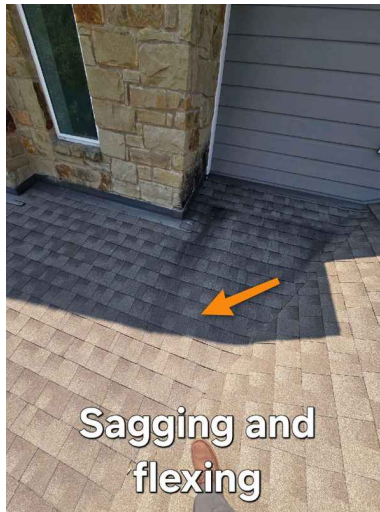
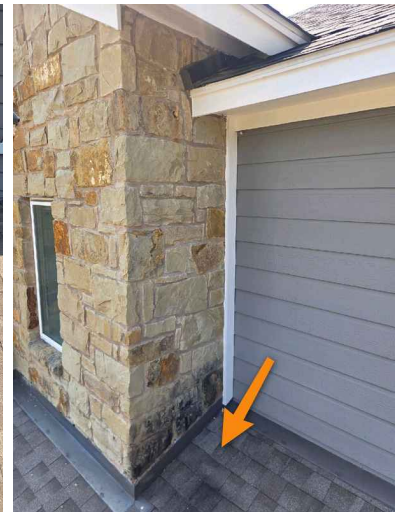
Exterior front

A soft, sagging area was discovered at the front of the roof during the walking inspection. This condition indicates possible water damage, or weakened roof decking that could lead to leaks or further deterioration. A qualified roofing contractor should evaluate the extent of the damage and recommend appropriate repairs.

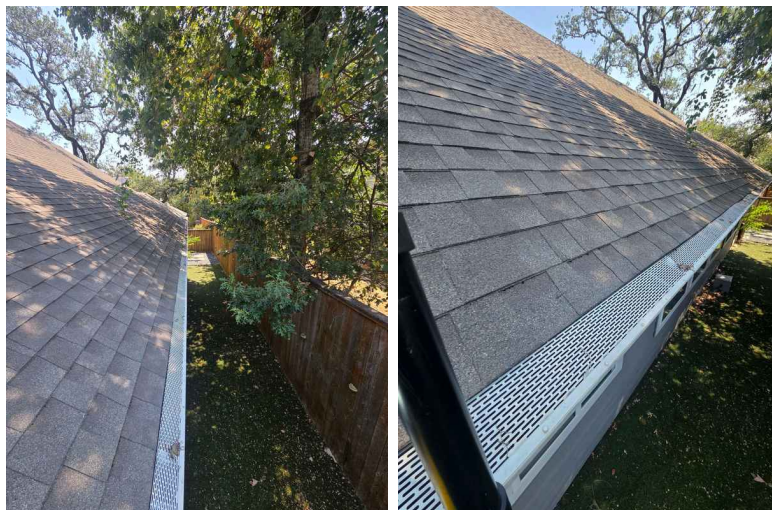
## 3: Tree Branches Near Roof Covering

Tree branches are located in close proximity to the roof covering. Branches touching or overhanging the roof can damage shingles, facilitate debris accumulation, and provide pathways for pests and rodents to access the structure. A minimum 5-foot clearance between tree branches and the roof is recommended to prevent these issues and maintain proper roof integrity.

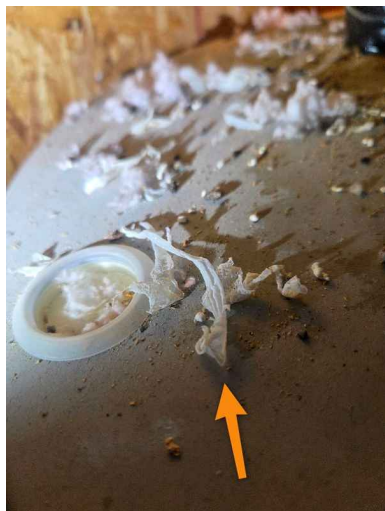
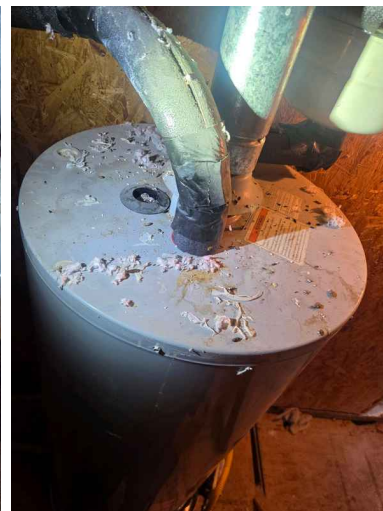
##### Attic

Evidence of previous pest activity was observed in the attic near the water heater during inspection. Pest activity can indicate conditions that attracted insects or rodents, such as moisture, food sources, or entry points.

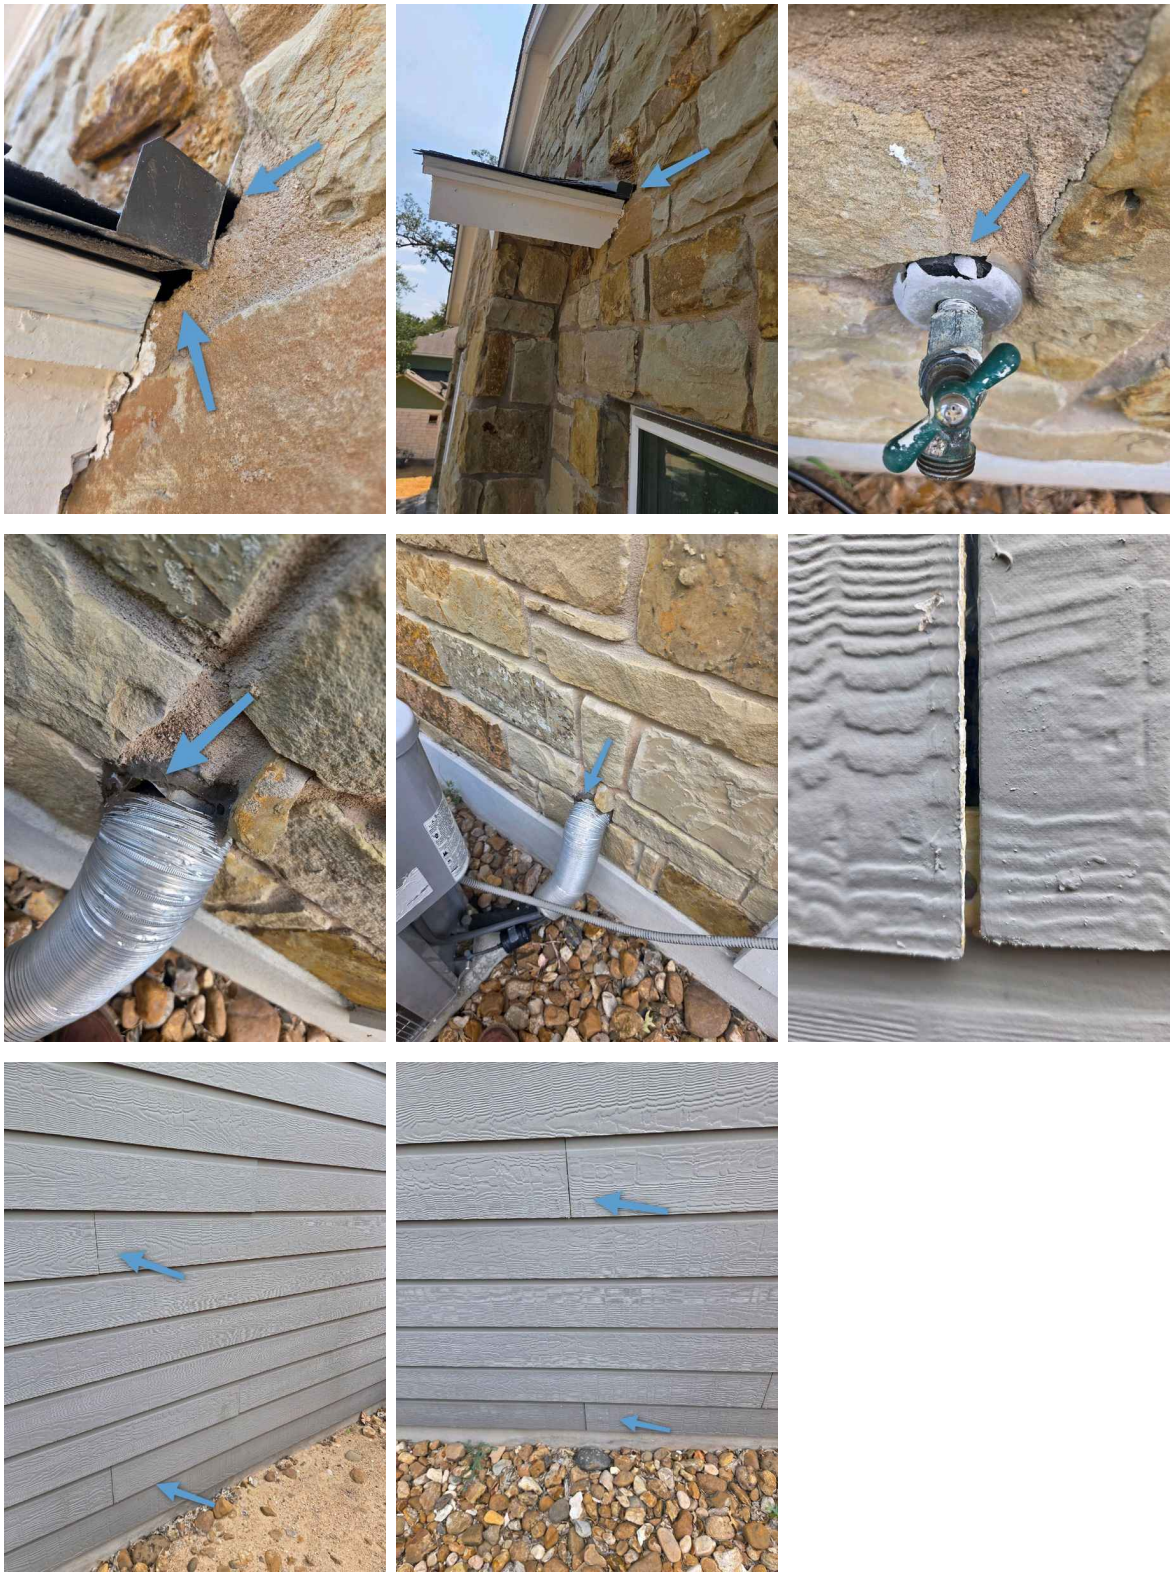
Gaps or openings were observed around exterior wall penetrations. These openings can allow moisture and pest entry into the wall assembly. Seal the affected areas with an appropriate exterior-grade sealant and maintain them as needed.

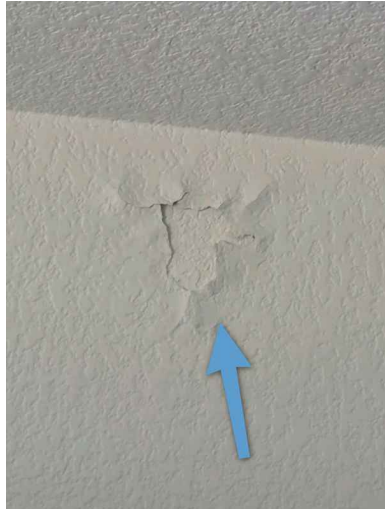
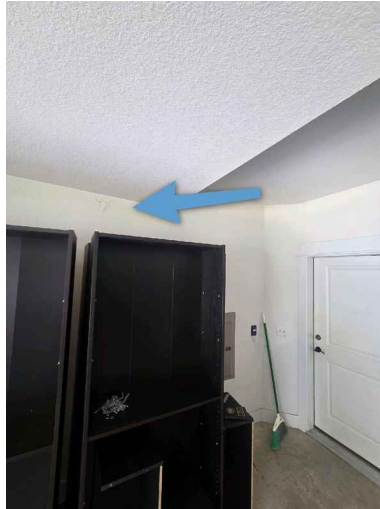
#### Garage

Damage or openings were observed in the interior wall finish. Repair the affected areas as needed to restore the wall surface and finish.

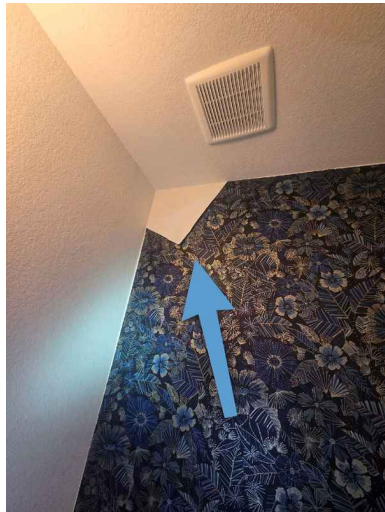
#### Bathroom

Wallpaper in the downstairs guest bathroom is peeling and requires repair.

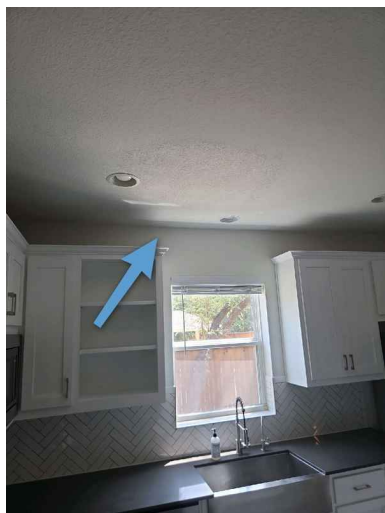
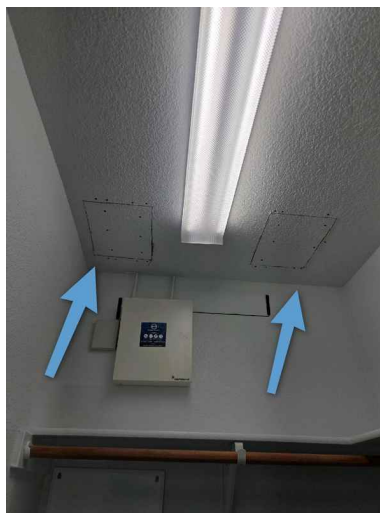
Bedroom closet and kitchen

Patching was visible in the ceiling in this room.

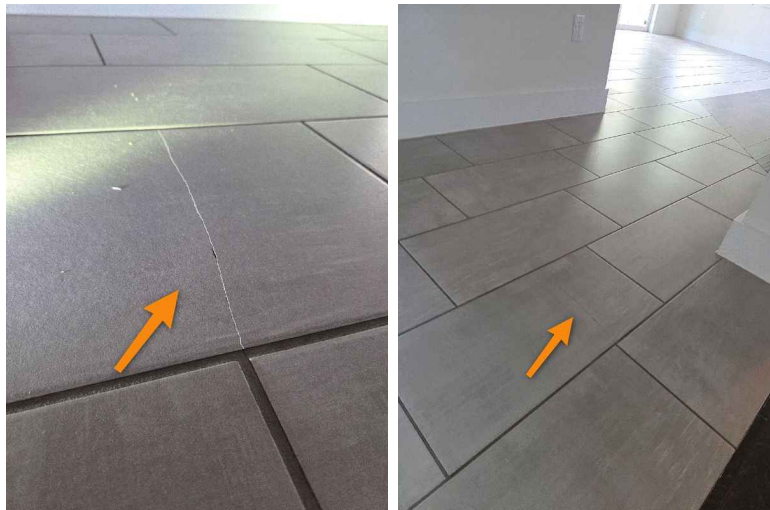
**2: Floor tile: cracked**

Floor tiles were cracked. You should ask the seller if spare tiles are available as matching replacements. You should consult with a qualified contractor to discuss options and costs for replacement.

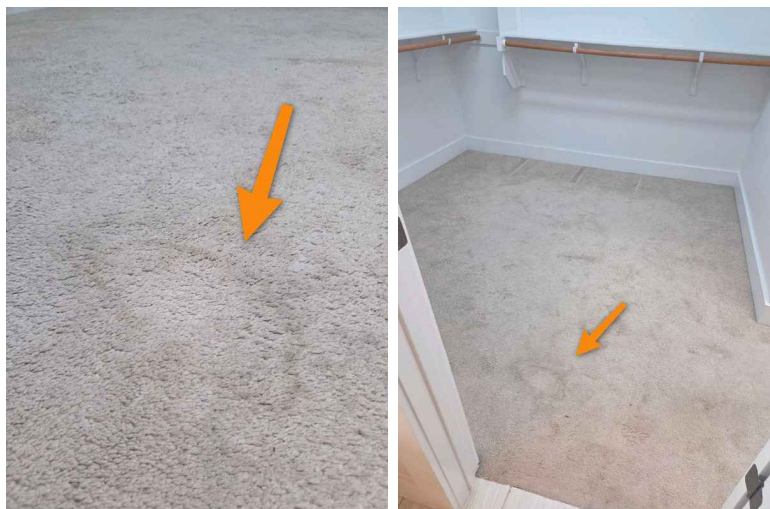
### 3: Carpet: damage, minor

The carpet had areas of minor carpet damage.

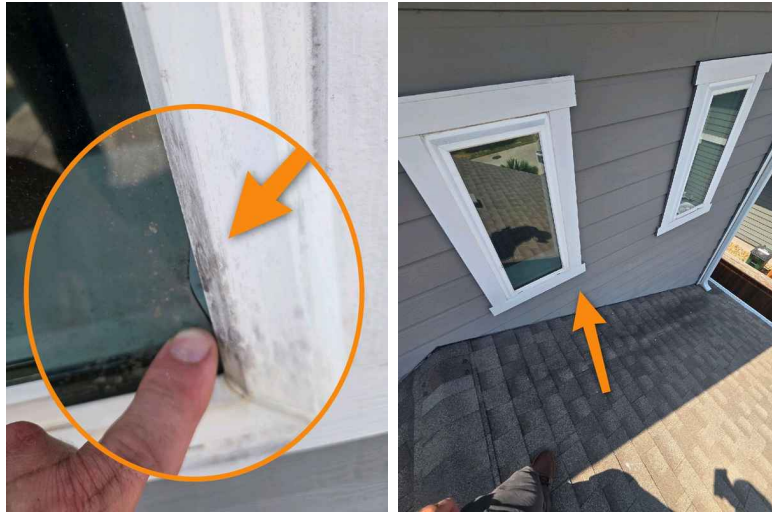
#### 1: Glazing: cracked pane

A window had a cracked pane.

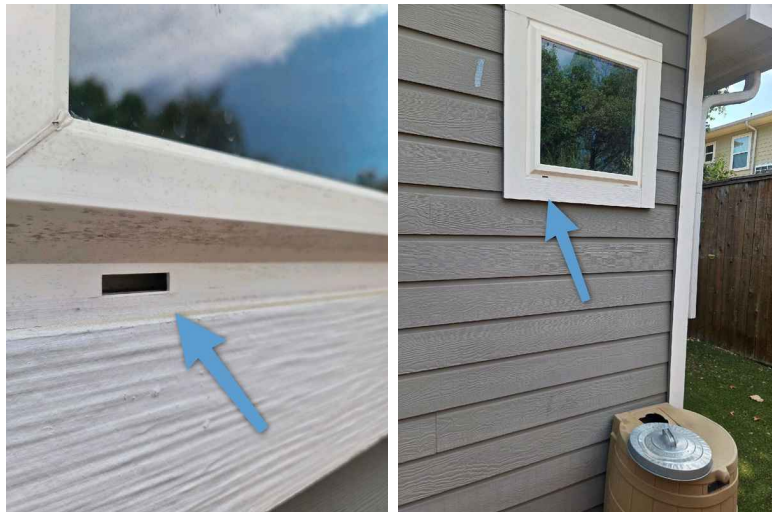
Exterior right

The weep hole cover is missing from the window frame. Install a replacement weep hole cover to restore proper drainage protection.

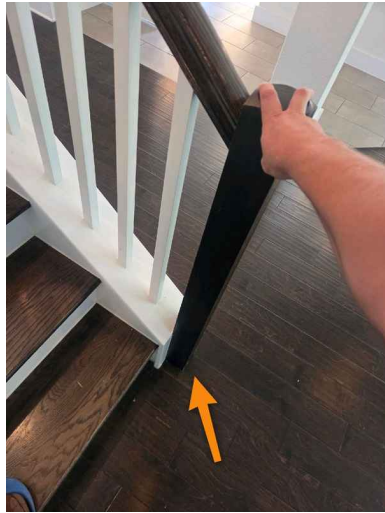
At this stairway, a stair guard support post was loose and should be made secure by a qualified contractor.

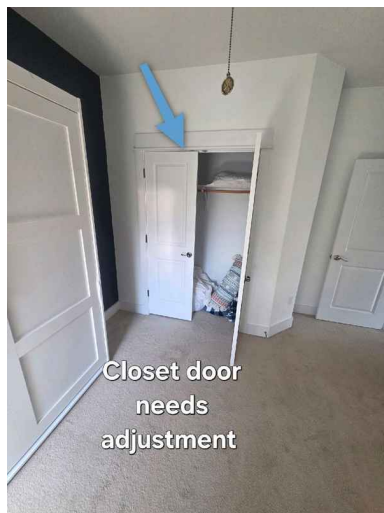
Upstairs closet

An interior closet door on the upper floor is difficult to operate. This may indicate misalignment, binding, or mechanical issues with hinges or the door frame. Have a carpentry contractor or handyman inspect the door assembly, check alignment, and make necessary adjustments or repairs to restore smooth operation.

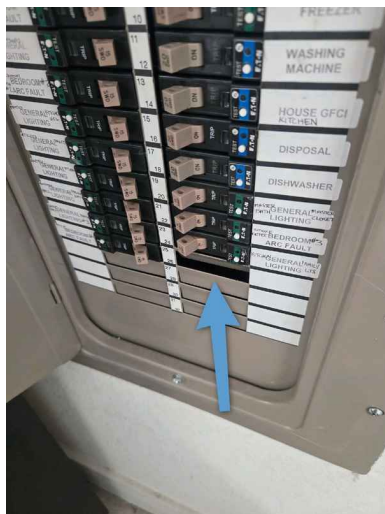
Garage panel

Unfilled holes or knockouts in the garage electrical panel may allow persons to come into contact with energized electrical components, may allow insect or rodent entry, or may allow moisture intrusion that can cause corrosion of interior components that can degrade electrical connections. This condition should be corrected by a qualified electrical contractor.

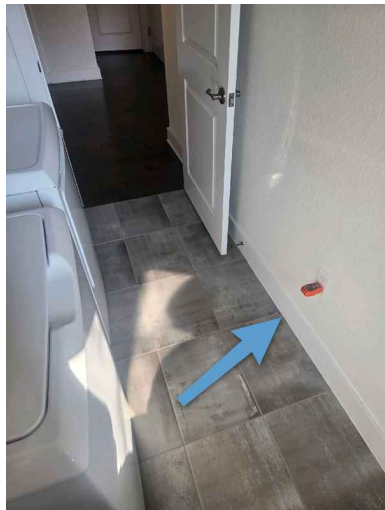
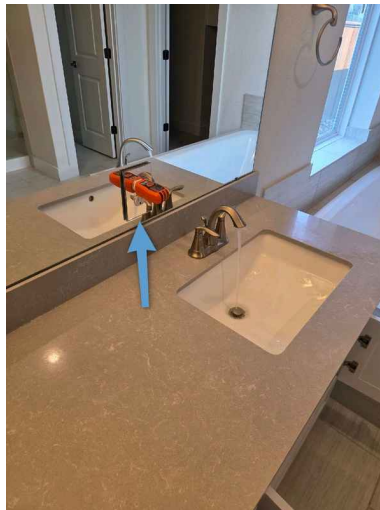
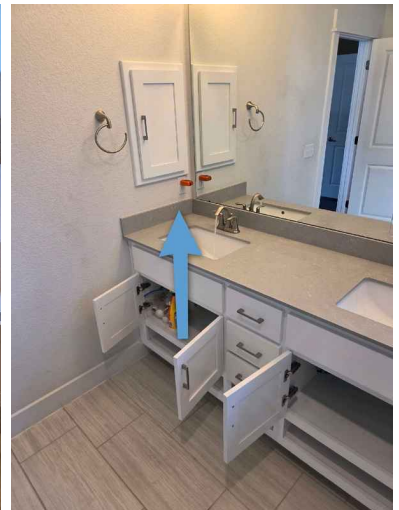
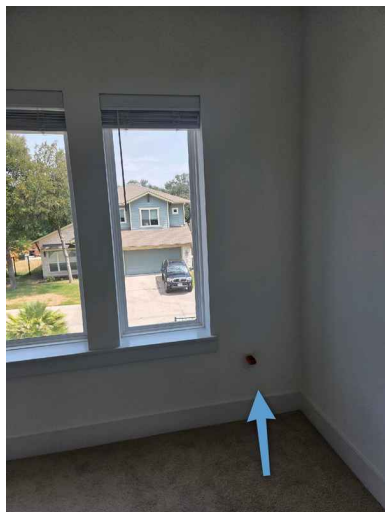
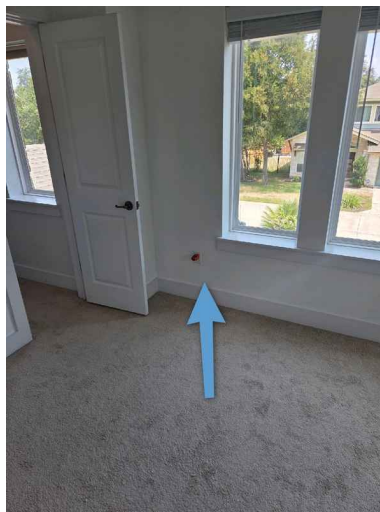
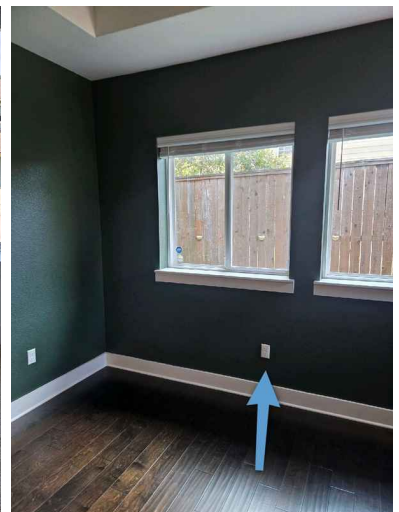
### 1: Receptacle: loose

An electrical receptacle was loose and moved when a plug was inserted. Correction should be made as necessary by a qualified electrical contractor.

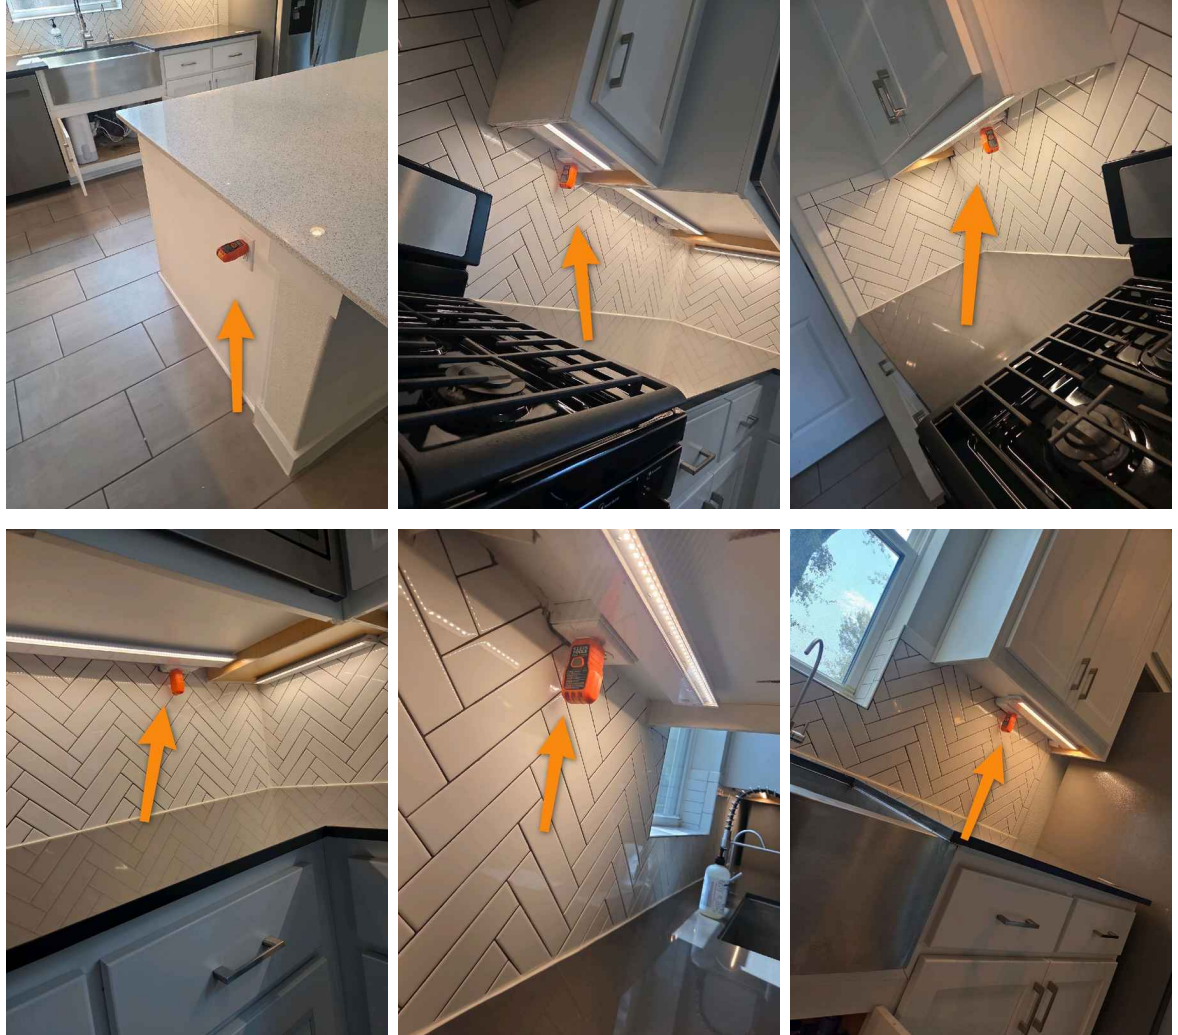
## 2: Receptacle: GFCI, failure to trip when tested

A ground fault circuit interrupter (GFCI) electrical receptacle in multiple locations did not trip when tested. All the GFCI receptacles should be checked and replaced as needed by a qualified electrical contractor.

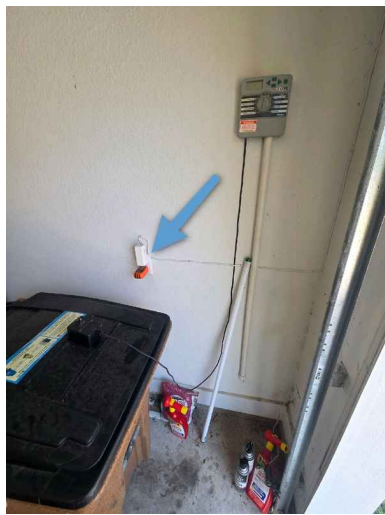
**5: Receptacle: exterior, hot/neutral reverse**

An exterior electrical receptacle had hot and neutral wires reversed. This condition is a potential electric shock hazard and should be corrected by a qualified electrical contractor.

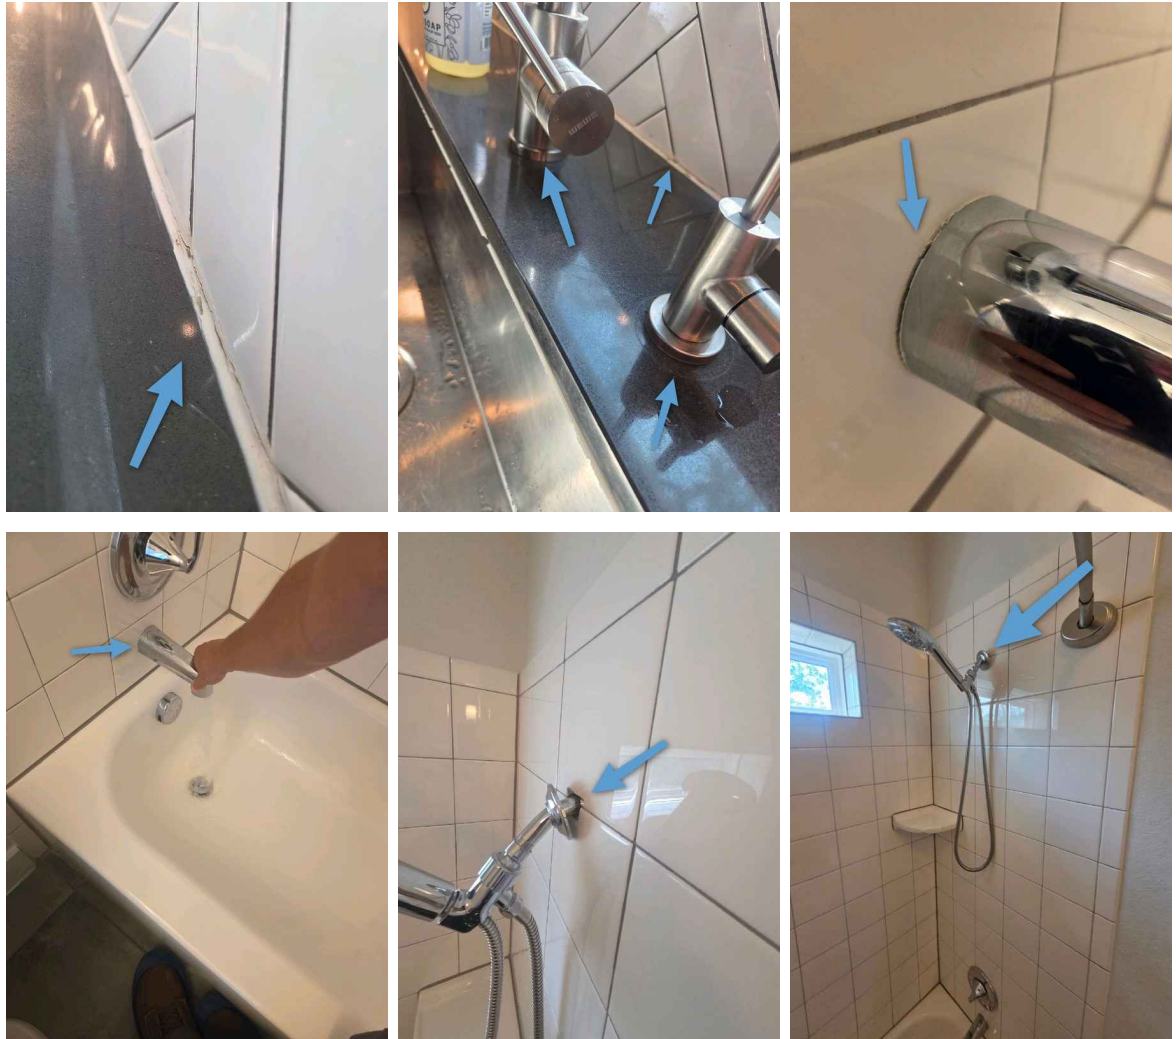
Bathroom, kitchen

Sealant at the shower was old and/or had sections of missing sealant that may allow damage from moisture intrusion of the wall assembly.

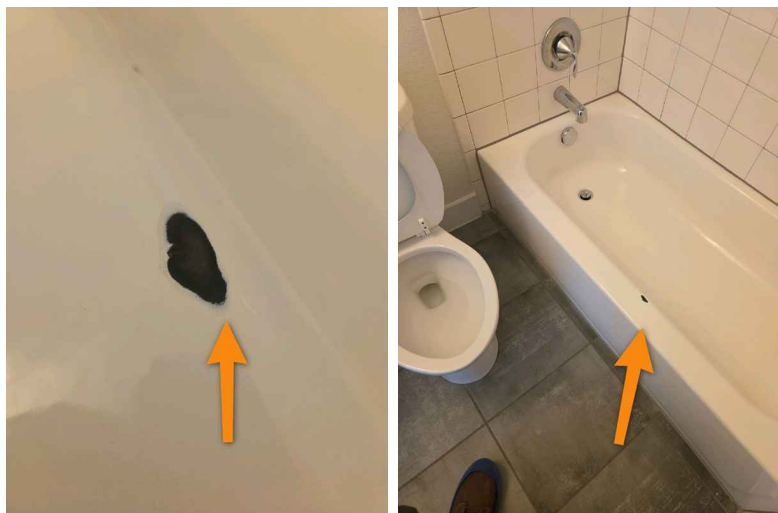
### 3: Bathtub: damage, moderate

The bathtub in this bathroom had moderate damage.

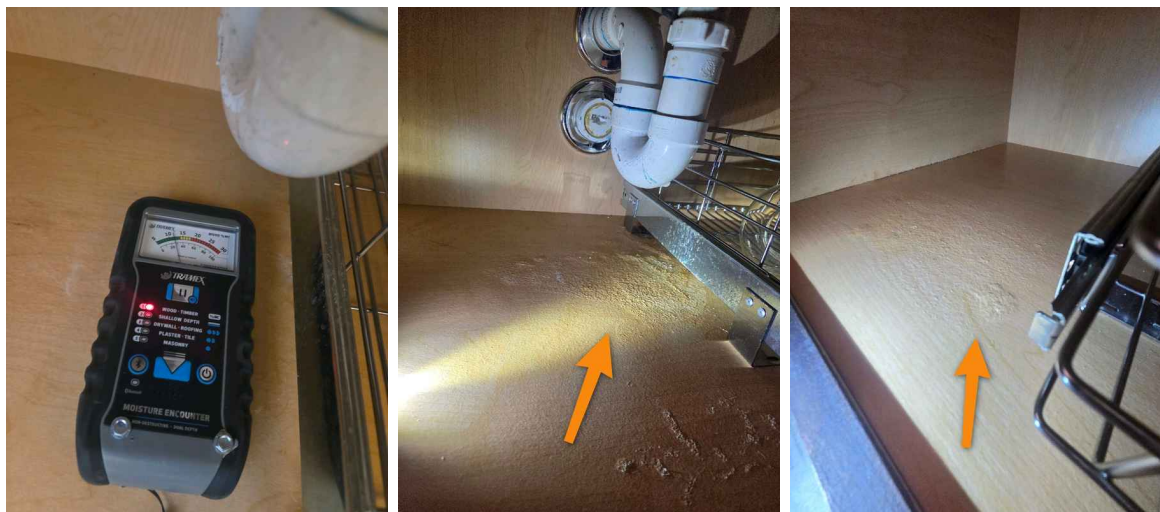
Upstairs bathrooms

The interior of an under-sink cabinet had moisture damage that was visible in materials beneath this bathroom sink. Moisture meter did not detect active moisture indicating this may have been a previous leak that has since been corrected.

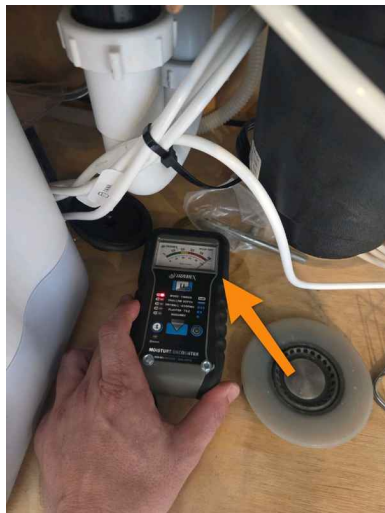
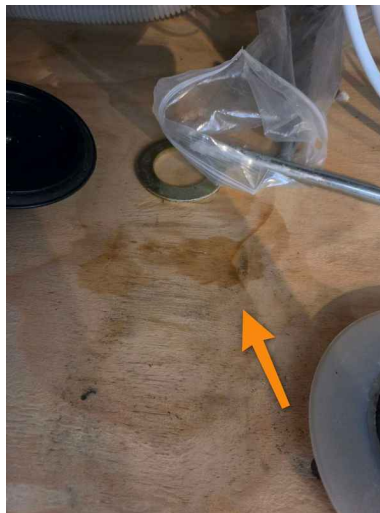
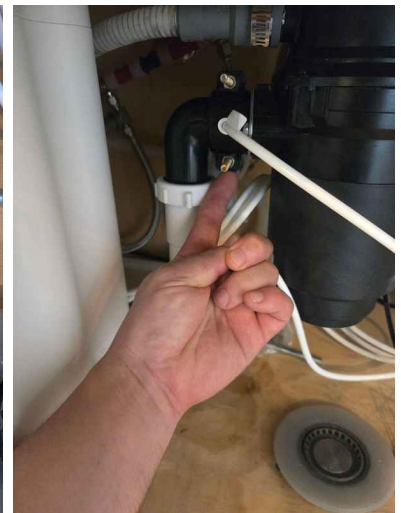
Kitchen

The interior of an under-sink cabinet had moisture damage that was visible in materials beneath the kitchen sink. Moisture meter detected active moisture indicating this is an active leak that needs a qualified plumbing contractor to correct.

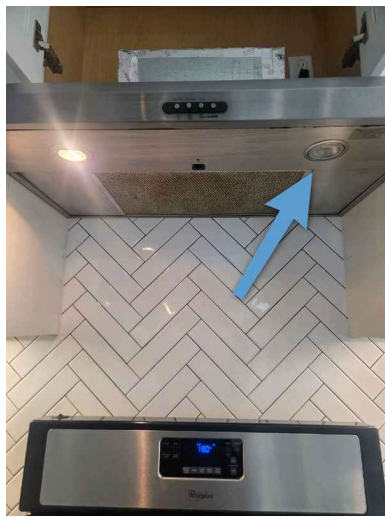
**1: Lights inoperable**

The range hood lights were inoperable. The bulb may be burned out, or there may be a problem with the switch, wiring or light fixture. If after replacing the bulb the light fixture still does not respond, the Inspector recommends service by a qualified contractor.

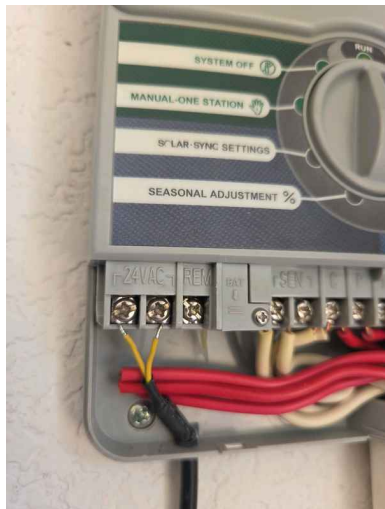
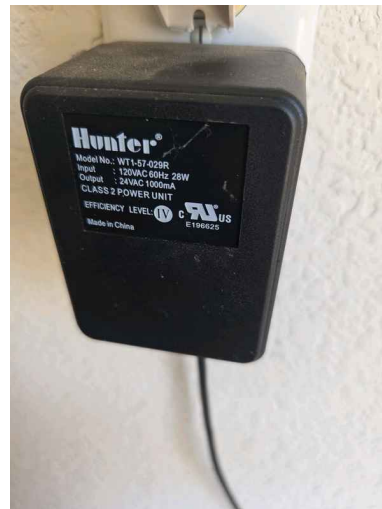
*Irrigation System Controller Inoperative:* The irrigation system controller failed to power on during inspection. Multiple outlet locations were tested with an extension cord without success, preventing evaluation of the sprinkler system's operation and components.
