1706 [REDACTED]

Cedar Park , TX, 78613

PROPERTY INSPECTION REPORT FORM

<input type="text"/>	January 29, 2025
Name of Client 1706 <input type="text"/> TX 78613	Date of Inspection
Address of Inspected Property Eaton Bates	26867
Name of Inspector	TREC License #
Name of Sponsor (if applicable)	TREC License #

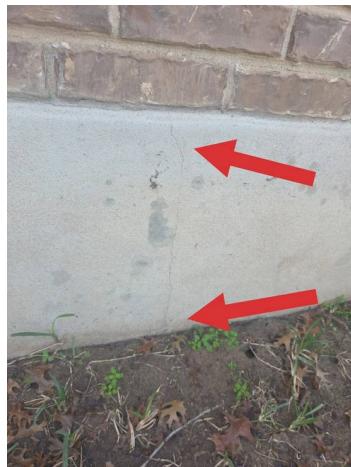
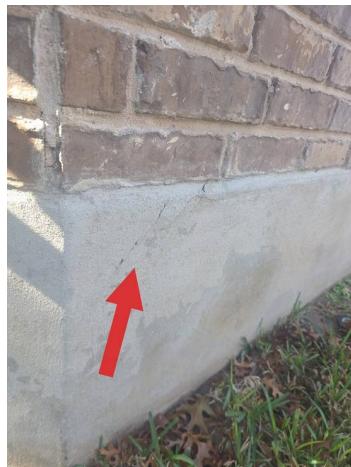
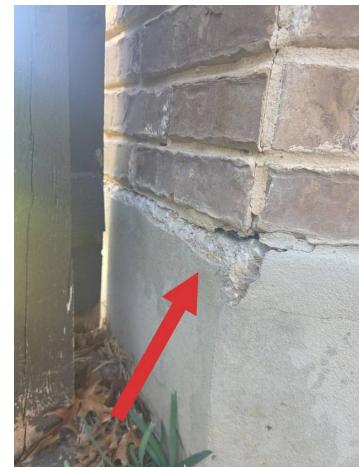
I. STRUCTURAL SYSTEMS **A. Foundations**

Foundation had minor cracking that is typical for a house of this age. Recommend a qualified handyman to seal the cracks and deterioration

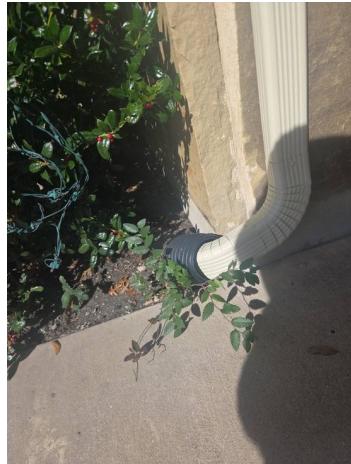
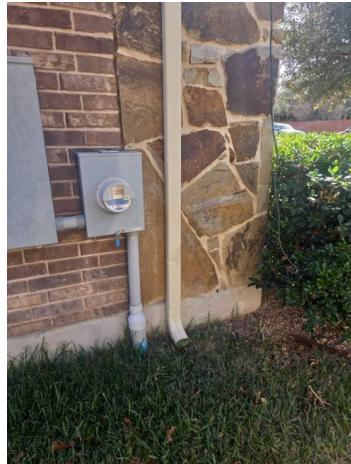
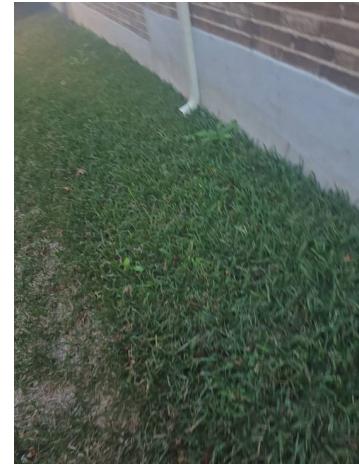
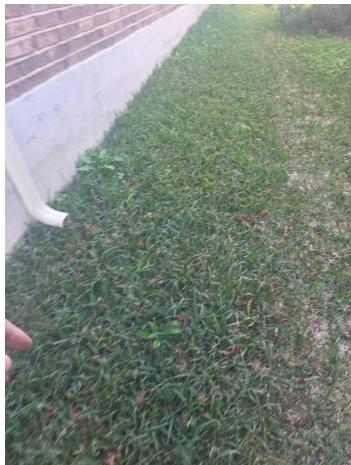
B. Grading and Drainage

A downspout terminated underground, the end was not visible. Recommend a qualified landscaping contractor to evaluate and correct to prevent water pooling near the foundation.

Splash blocks are recommended at gutter downspouts to ensure water quickly flows at least 5ft away from the foundation, this will help mitigate the risk of foundation movement due to excessive water

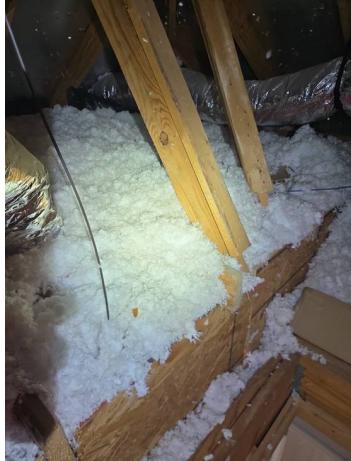
D. Roof Structures and Attics

Average depth of 14 inches blown in fiberglass insulation observed at the time of the inspection

Attic structure appeared to be performing as intended at the time of the inspection

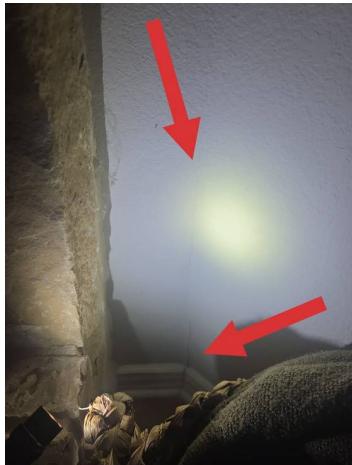
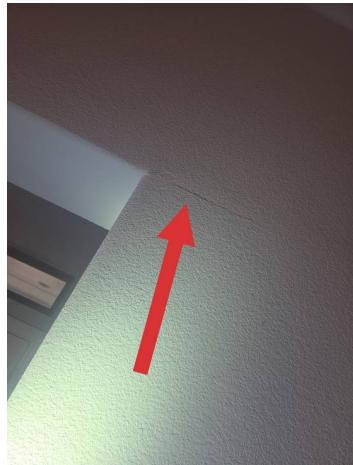
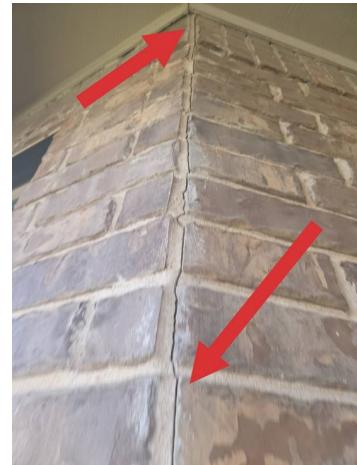
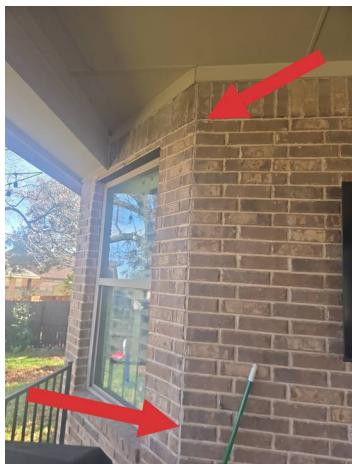
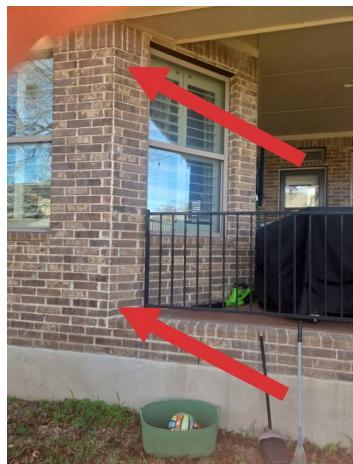
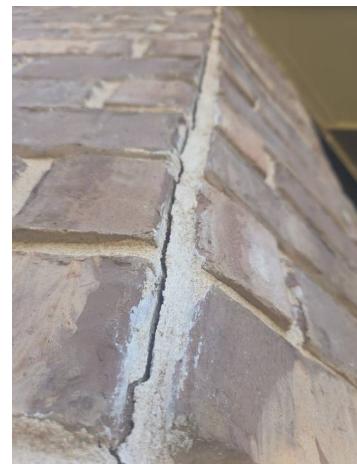
E. Walls (Interior and Exterior)

Interior and Exterior cracks at multiple locations. Many of them at joints where this cracking is typical. Recommend mason to seal exterior cracks to prevent moisture intrusion

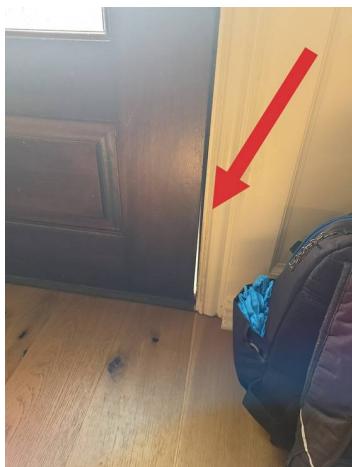
G. Doors (Interior and Exterior)

Gap at front door, recommend to improve weather stripping to prevent air leakage and pests

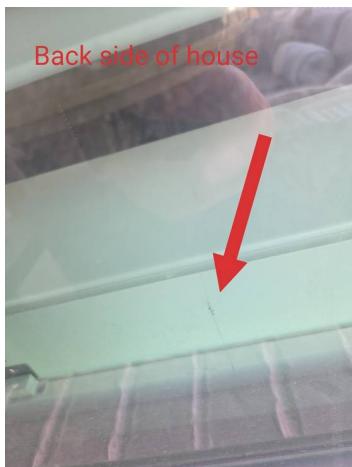
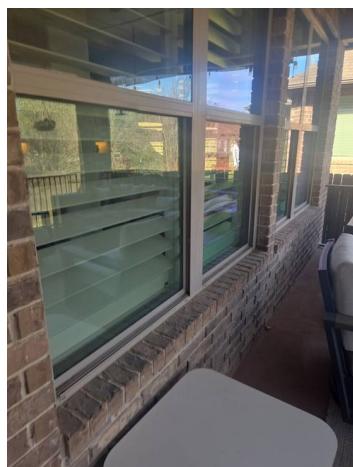
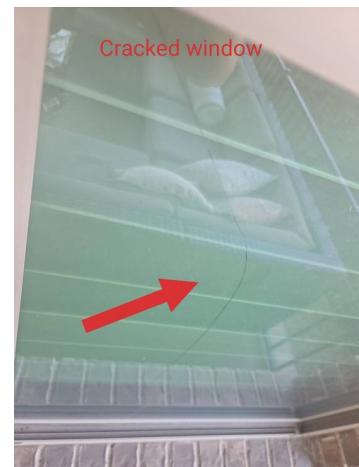
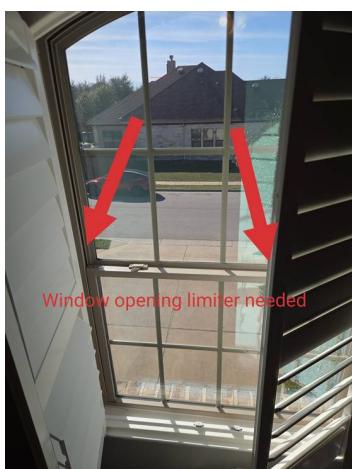
H. Windows

Crack in window at back side of the house

Windows didn't properly latch/lock shut at many of the windows. This is necessary for security, recommend correction by a qualified contractor

Missing screens at multiple windows. Recommend replacement to prevent pests entering the home with windows opened

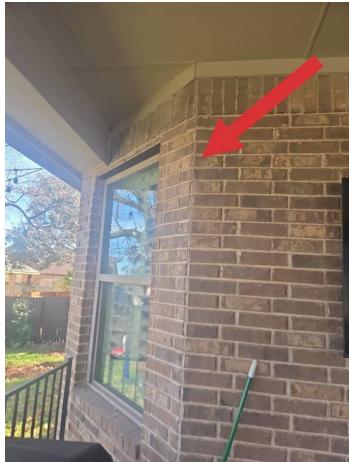
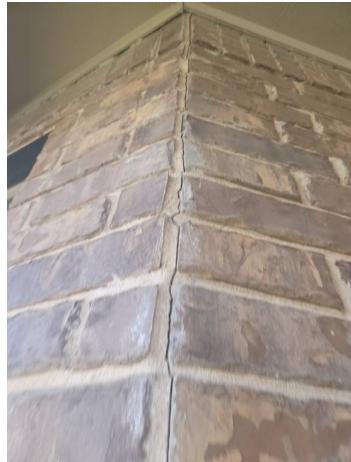
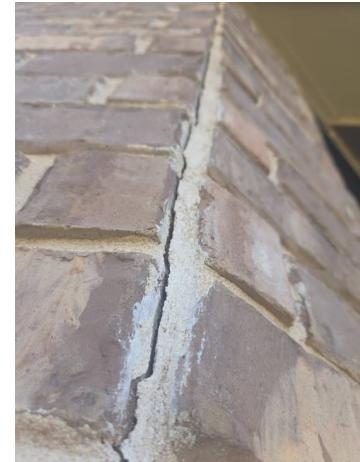
K. Porches, Balconies, Decks, and Carports

Back porch wall covering had cracks at the mortar joints. Recommend repair to prevent moisture intrusion and further deterioration

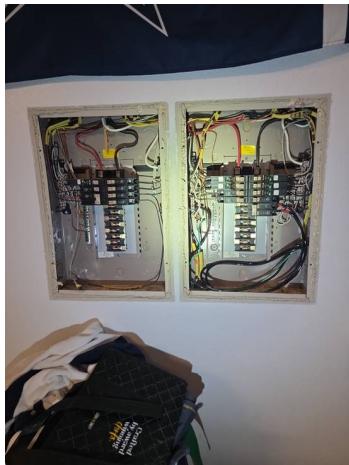
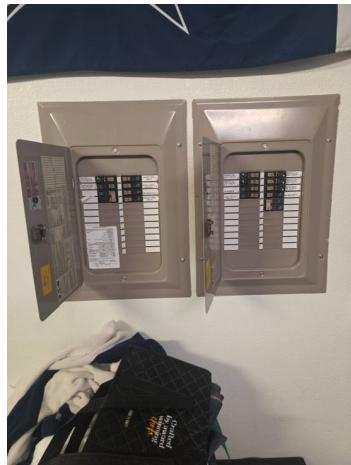
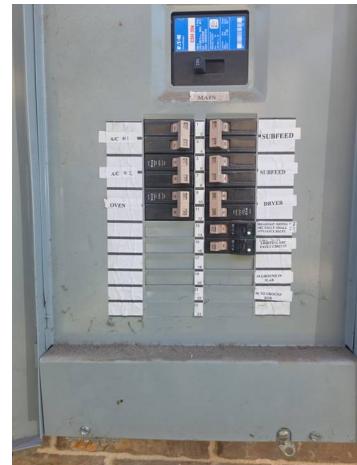
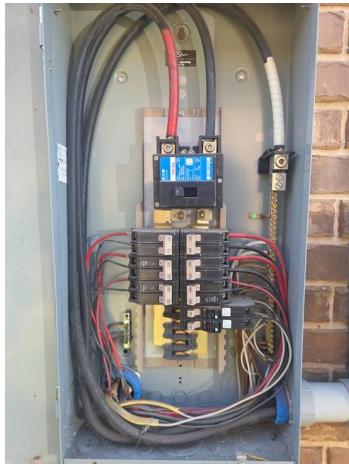
A. Service Entrance and Panels

Service panel appeared to be performing as intended at the time of the inspection.

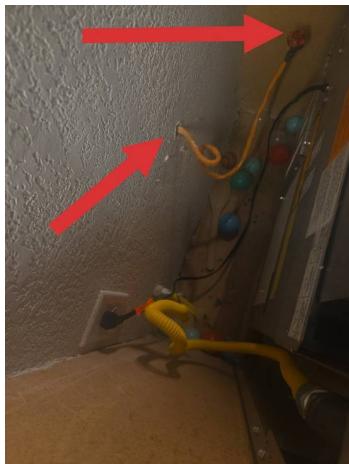
B. Branch Circuits, Connected Devices, and Fixtures

240v circuit missing junction box and cover plate. Recommend qualified electrician to correct to prevent damage to electrical wiring

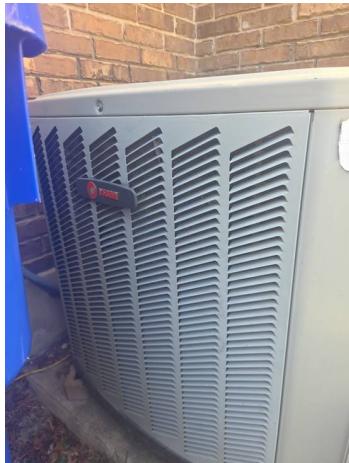
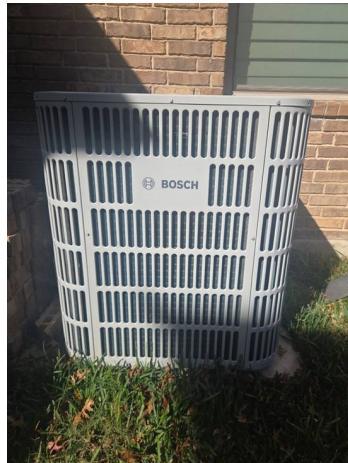
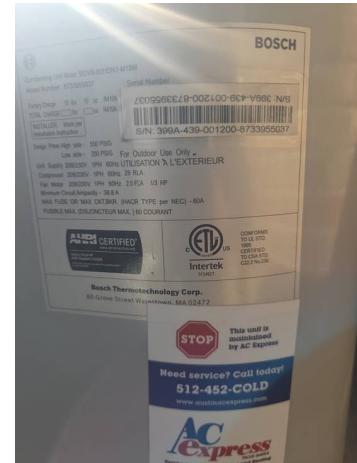
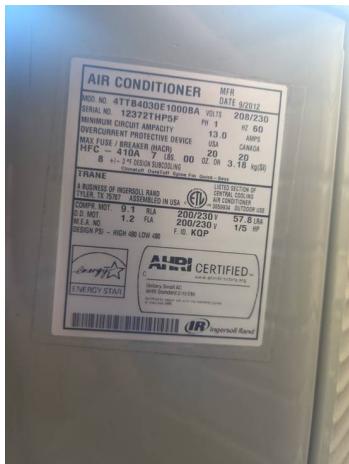
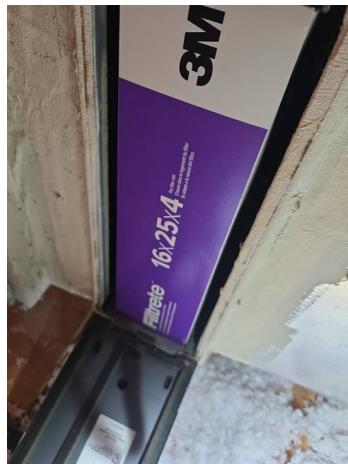
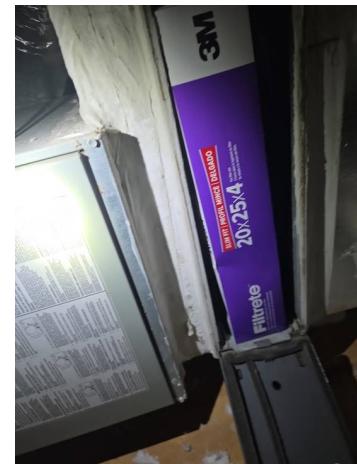
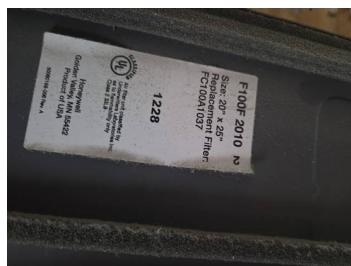
B. Cooling Equipment

Cooling temperature differential between the return air and multiple supply registers averaged approximately 12°F when measured with an infrared thermometer. Typical expected temperature differential under normal operating conditions is approximately 15–22°F. Outdoor temperature at the time of inspection was approximately 65°F, which can limit the accuracy of cooling performance testing. System performance may be further evaluated by a qualified HVAC contractor if desired.

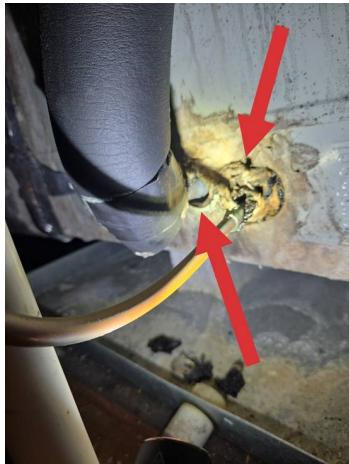
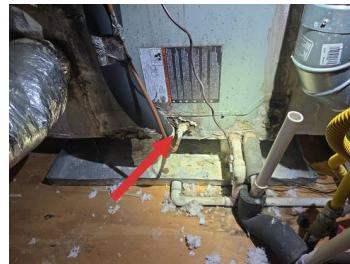
C. Duct Systems, Chases, and Vents

Ducting at the air handler appeared to be not well sealed. Recommend qualified HVAC professional to evaluate and correct to prevent energy loss.

unsealed ductwork was present and can decrease the system's efficiency

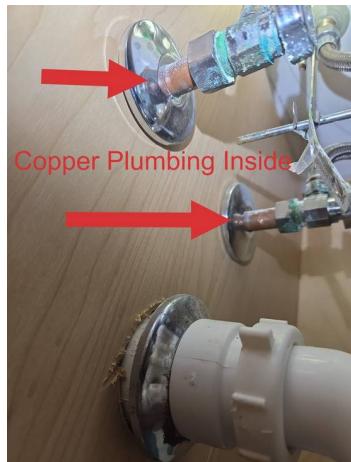
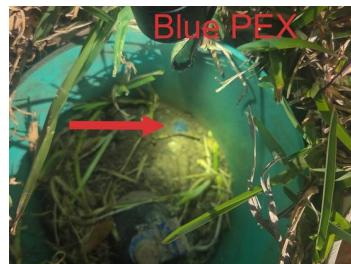
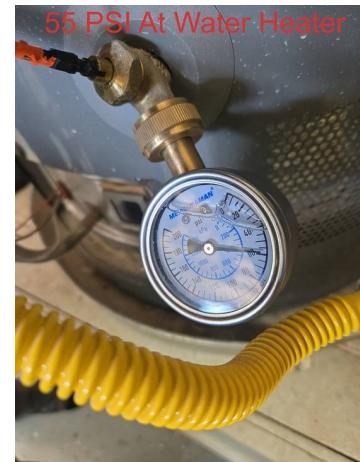
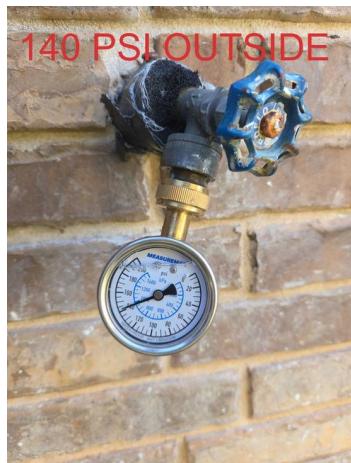
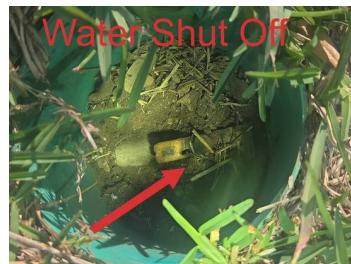
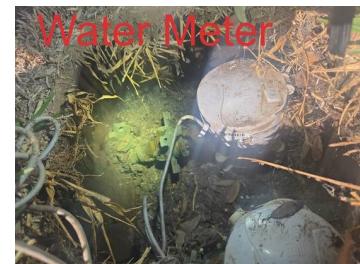
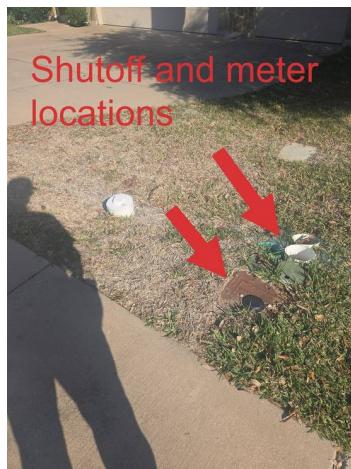
IV. PLUMBING SYSTEMS**A. Plumbing Supply, Distribution Systems and Fixtures**

Copper supply plumbing observed inside at multiple fixtures

Blue pex observed after the pressure reducing valve near the main water shut off

135 psi reading observed at the outside spigots. 60 psi at the water heater. Recommend qualified plumber to evaluate further. High pressure can be a risk for plumbing leaks

Water pressure was too high

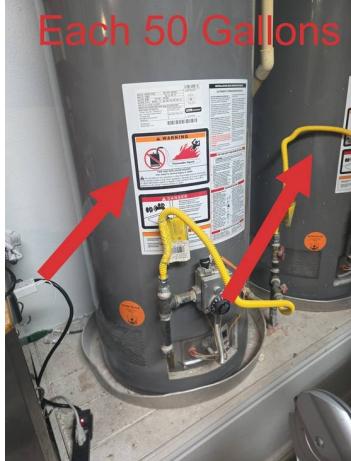
C. Water Heating Equipment

Two 50 gallon natural gas water heaters observed for a total of 100 gallon capacity

Water was dangerously hot (135f) at multiple sinks and tubs indoors. Recommend correction to prevent scalding water.

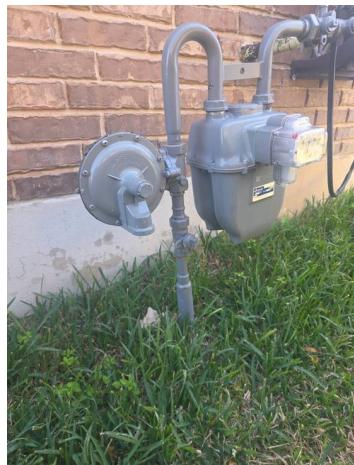
D. Hydro-Massage Therapy Equipment**E. Gas Distribution Systems and Gas Appliances**

Gas functioned as intended at the time of the inspection. No notable smell of leaking gas noted

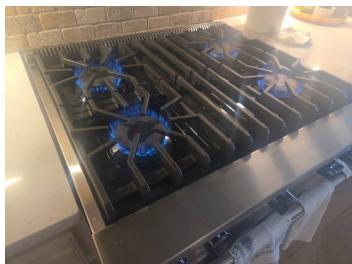
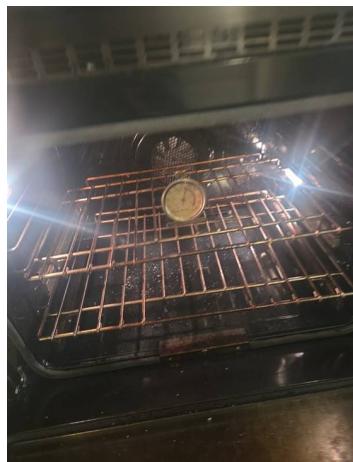
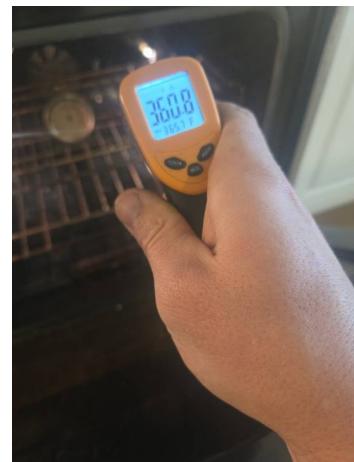
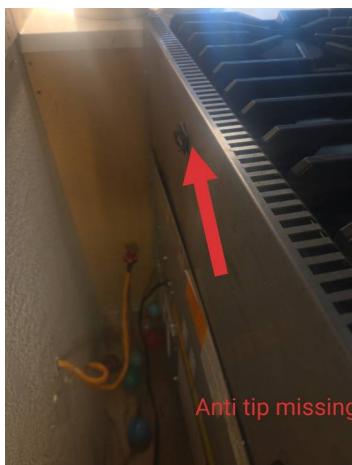
D. Ranges, Cooktops, and Ovens

Anti tip device on oven missing. Recommend handyman to install to prevent accidental tipping over

Oven 360f when set to 350f. This is typical and within a good range of accuracy

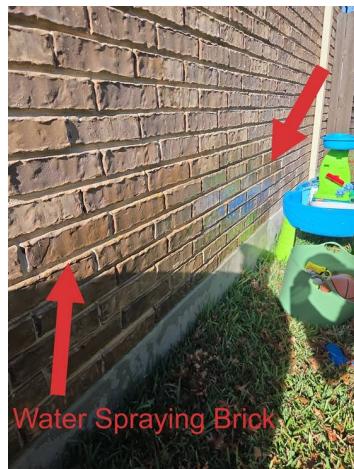
I. Other**VI. OPTIONAL SYSTEMS** **A. Landscape Irrigation (Sprinkler) Systems**

All irrigation heads need to be adjusted to ensure no water is spraying against the home's exterior or foundation. Recommend a qualified irrigation contractor to evaluate and correct

Zone 8 was not tested but appeared to be not functional. Zones 1-7 performed as intended at the time of the inspection (5 was skipped automatically on the controller)
