TREC 7-6 RESIDENTIAL INSPECTION

146 Gold Rush Dr
Cedar Park, TX 78613

PROPERTY INSPECTION REPORT FORM

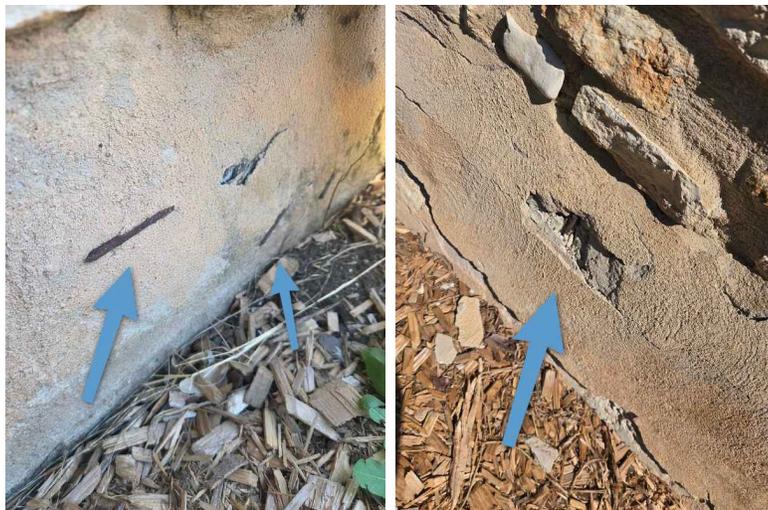
1: Concrete foundation walls: deterioration, minor, exterior

Portions of the concrete foundation wall surfaces exposed to weather exhibited minor deterioration.

Recommend qualified contractor to seal and patch to prevent further damage from moisture intrusion.

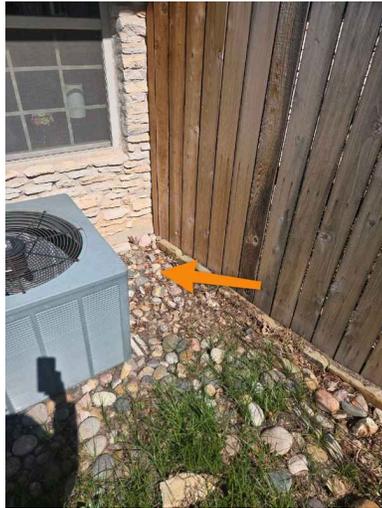
The home had areas of neutral or negative drainage that will route runoff from precipitation toward the foundation. To help reduce the risk of foundation damage, the ground should slope away from the home a minimum of 1/4-inch per foot for a distance of at least six feet from the foundation.

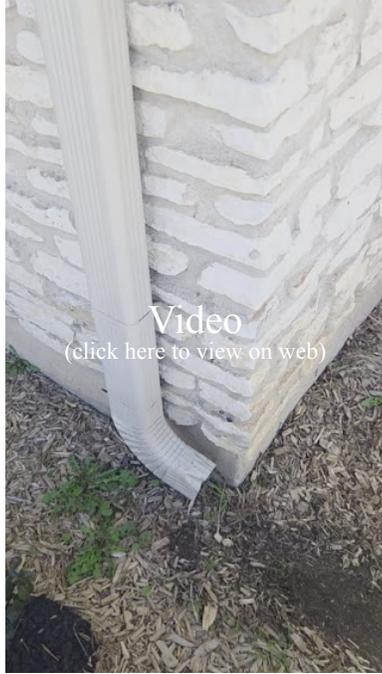
2: Roof drainage: downspouts, discharge to foundation

One or more downspouts discharged roof drainage next to the foundation. This condition can result in high moisture levels in soil at the foundation that can cause damage related to soil/foundation movement. Downspout extensions should be installed to discharge roof drainage away from the foundation.

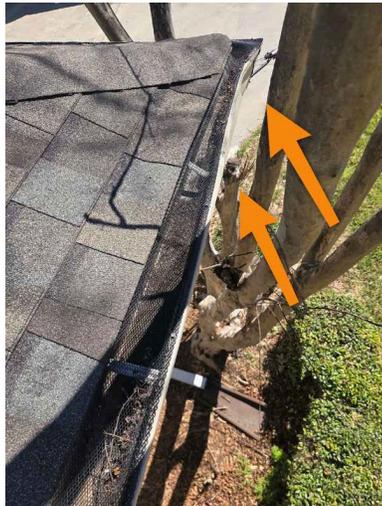
3: Roof drainage: gutters bent / damaged

The gutters were bent or damaged. This condition can result in excessively high moisture levels in soil near the foundation that can cause damage related to soil/foundation movement. Damaged gutter sections should be replaced by a qualified contractor.

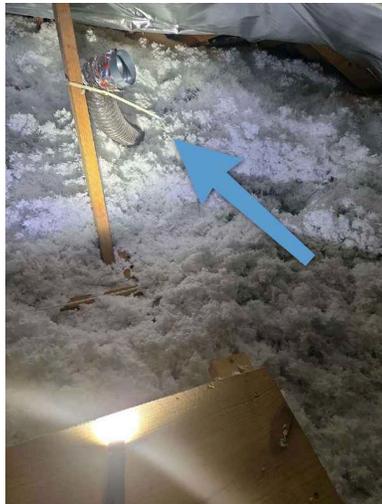
1: Attic ventilation: bathroom fan duct terminates in attic, old home, OK
 Minor Concern

A bathroom exhaust vent terminated in the attic instead of at the home exterior. This condition can raise moisture vapor levels in the attic to the point at which home materials are damaged or unhealthy conditions related to mold develop. This installation may have been acceptable at the time of original construction. No problems that appeared to be related to this condition were observed.

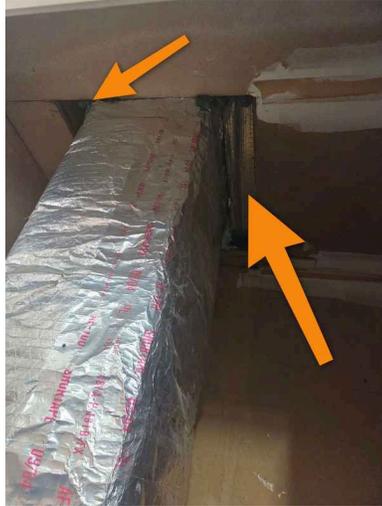
The garage ceiling had holes at the time of the inspection. These holes should be repaired to provide an intact fire-resistant barrier between the garage and the adjoining living space.

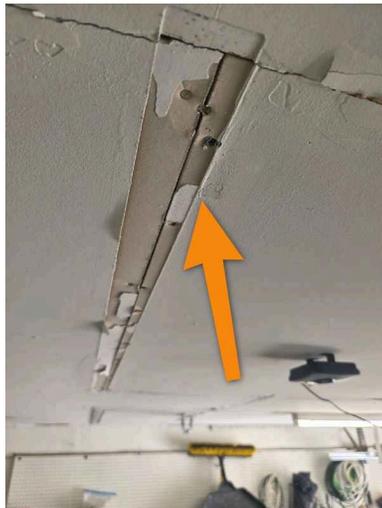
3: Fire separation: ceiling, no fire-taping

Garage ceilings were drywalled, but not fire-taped. Modern building practices require that fire-taped drywall be installed on any ceiling adjoining living space for safety reasons. The Inspector recommends drywall be fire-taped to comply with modern safety requirements related to safety hazards.

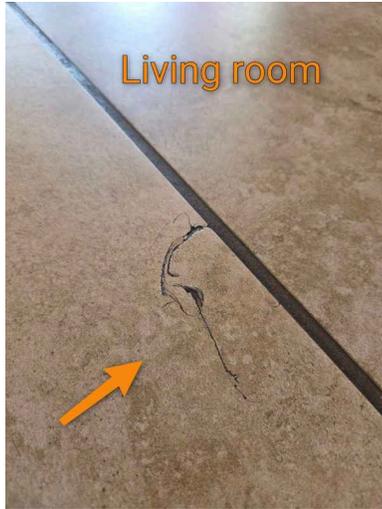
4: Floor tile: cracked

Floor tiles were cracked. You should ask the seller if spare tiles are available as matching replacements. You should consult with a qualified contractor to discuss options and costs for replacement.

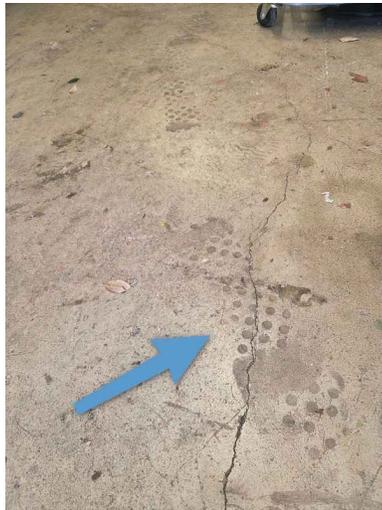
5: Garage floor: cracks, shrinkage, OK

The garage floor had common shrinkage cracks. These cracks are not a structural concern.

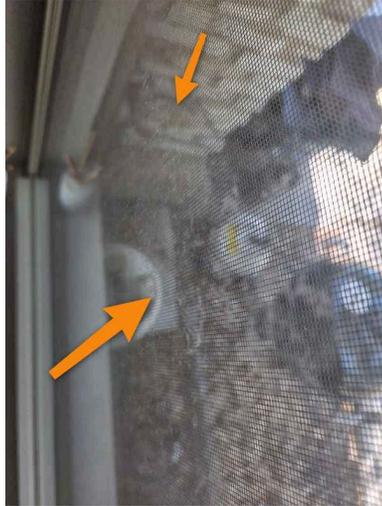
Condensation visible in the double-pane glazing of some windows indicated a loss of thermal integrity. You should consult with a qualified contractor to discuss the need, options, and costs for repair or replacement.

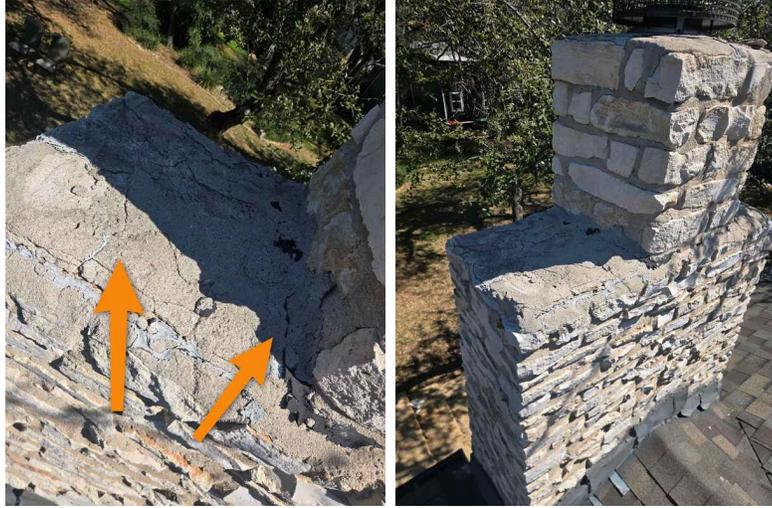
1: Chimney crown: cracking, moderate

Moderate cracking visible in the chimney crown should be filled with an appropriate sealant by a qualified masonry contractor to prevent worsening damage caused by moisture in the cracks expanding as it freezes.

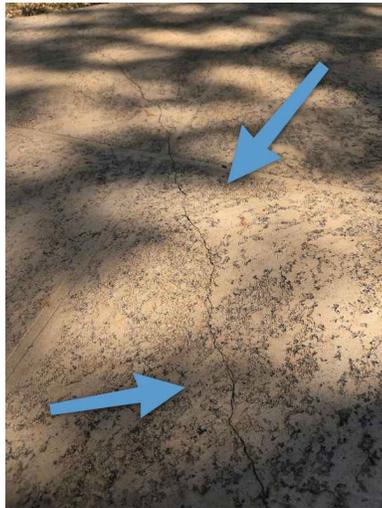
1: Patio concrete slab: shrinkage cracks

The concrete patio slab had shrinkage cracks visible. Shrinkage cracks are common surface cracks and are not a structural concern.

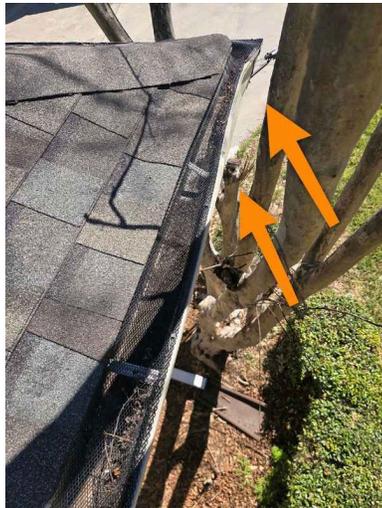
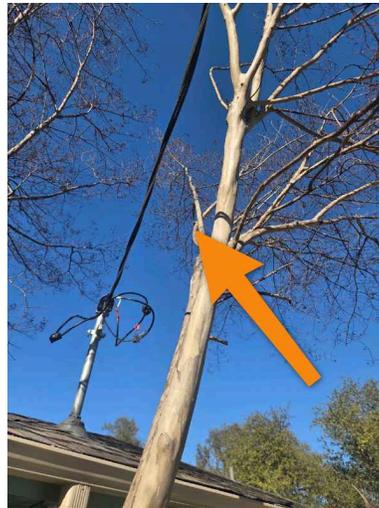
1: Service drop: clearance from trees- monitor

The overhead electrical service conductors were routed near tree branches. Although this did not appear to be a problem at the time of the inspection, as tree branches grow they may begin to contact and abrade the service conductors during windy periods.

To avoid conductor damage from abrasion, you should monitor this condition and arrange to have tree branches cut back as necessary. Work around the service conductors should be performed by a qualified personnel only.

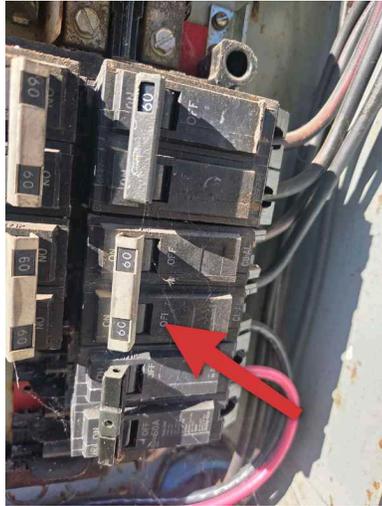
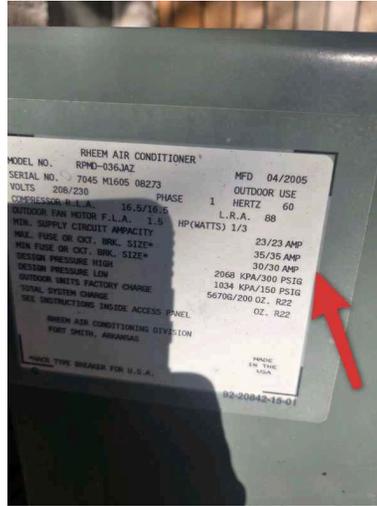
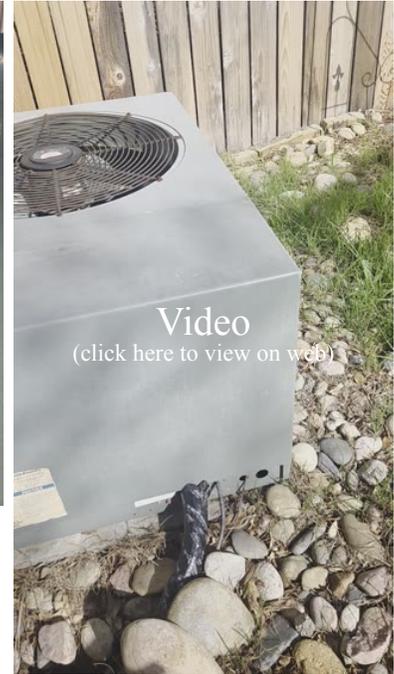
Fuses of excessive amperage (60 amps when 35 amps is called out on the air conditioning condenser label) were installed the electrical service panel. This condition is a potential fire hazard. The Inspector recommends immediate correction by a qualified electrical contractor.

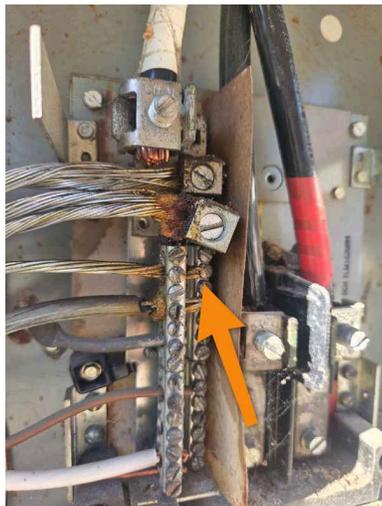
4: Service panel: interior, corrosion

The interior of the electrical service panel cabinet exhibited moderate amounts of corrosion indicating some moisture intrusion. Corrosion can degrade electrical connections, a potential fire hazard. The panel should be serviced by a qualified electrical contractor.

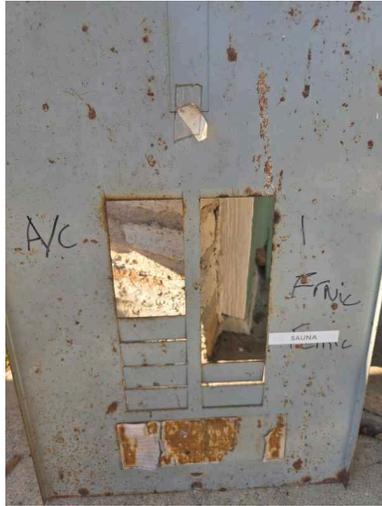
5: Service panel: label, circuit directory, missing

The electrical service panel circuit directory label was missing. A properly-marked circuit directory should be installed by a qualified electrical contractor so that individual circuits can be quickly identified and shut off during an emergency.

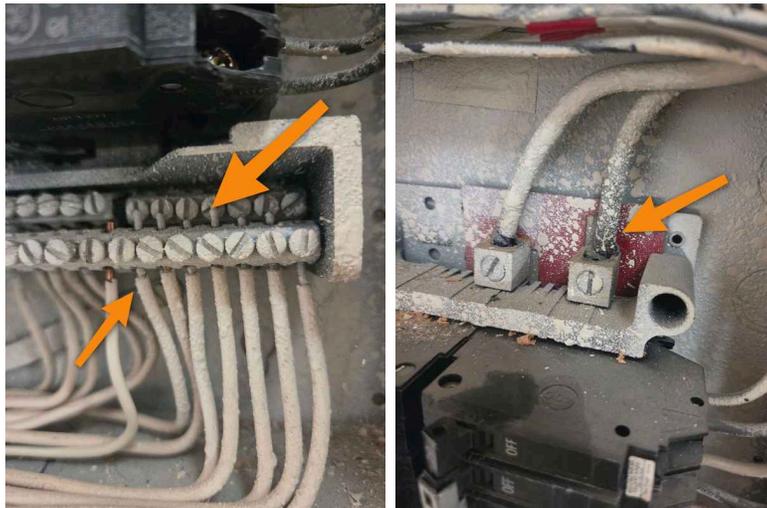
6: Sub-panel: interior, paint overspray

The interior of this electrical sub-panel was contaminated with paint overspray. This condition can deteriorate electrical connections, a potential fire hazard. The panel interior should be cleaned by a qualified electrical contractor.

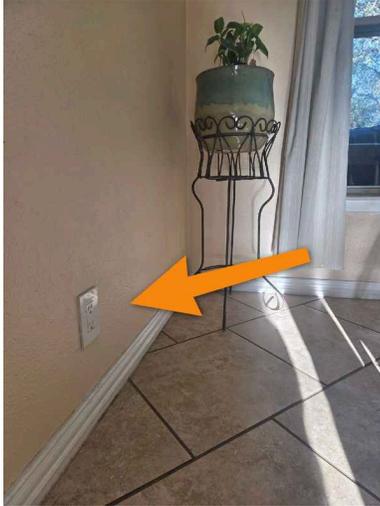
2: Receptacle: loose

An electrical receptacle was loose and moved when a plug were inserted, a potential fire/electrical shock hazard. Correction should be made as necessary by a qualified electrical contractor.

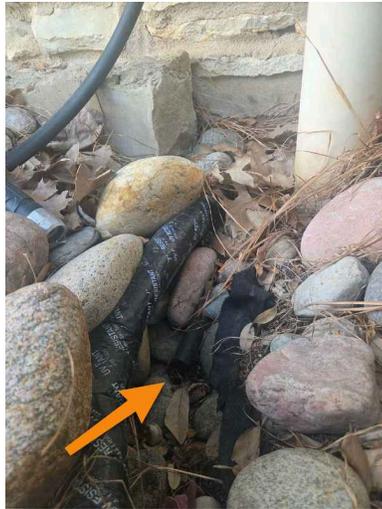
The condensate disposal tube discharge too low to the ground. This condition may result in tube blockage that will shut down the air-conditioning system until the blockage is cleared.

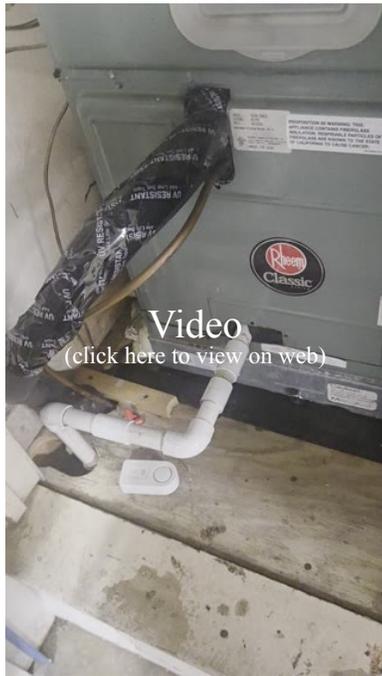
2: AC condensate disposal: no overflow pan

The attic-installed cooling system evaporator coils had no secondary condensate drain pan installed. If the primary condensate drainage system should fail, this condition could result in moisture damage to attic or home materials. A secondary drainage system such as a pan with an overflow routed to discharge properly should be installed by a qualified HVAC contractor.

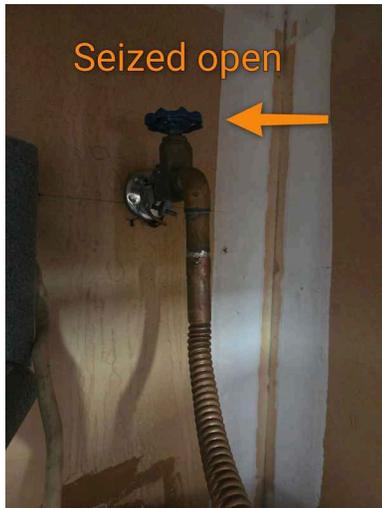
No operable cold water shut-off was installed at the water heater. This condition will complicate service. A shut-off should be installed by a qualified plumbing contractor.

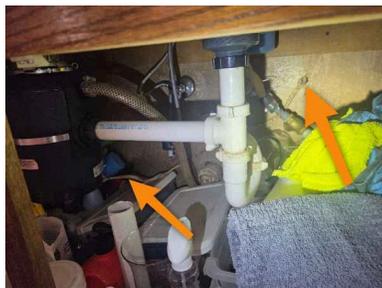
1: Electrical connection improper

The electrical connection to the garbage disposal was missing protective bushings at the disposal motor and should not pass through a open hole at the back of the cabinet. This is a risk for mechanical damage to the wiring and electrical shock hazard. The disposal should either be powered by an approved appliance cord plugged into a dedicated outlet, or be wired directly to a 20-amp gfci overcurrent protection device. This condition should be corrected by a qualified electrician.
