# AUSTIN REAL ESTATE INSPECTIONS (SPA)

## TREC 7-6 RESIDENTIAL INSPECTION

1234 Main Street  
Cedar Park TX 78613

08/29/2026 9:00AM

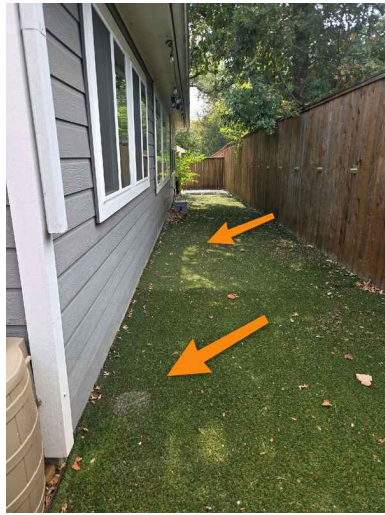
## 2: Roof drainage: downspouts, discharge to foundation

⚠️ Moderate Concern

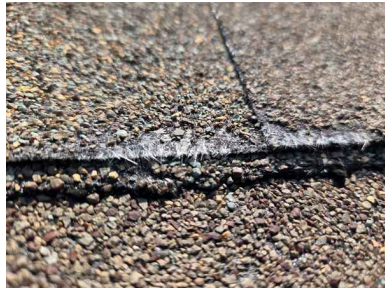
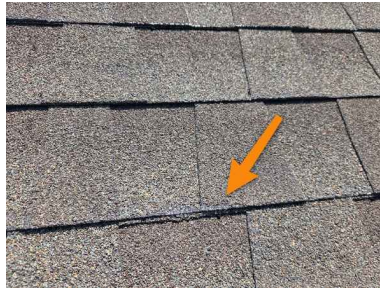
## 2: Soft Sagging Roof Spot

🟡 Moderate Concern

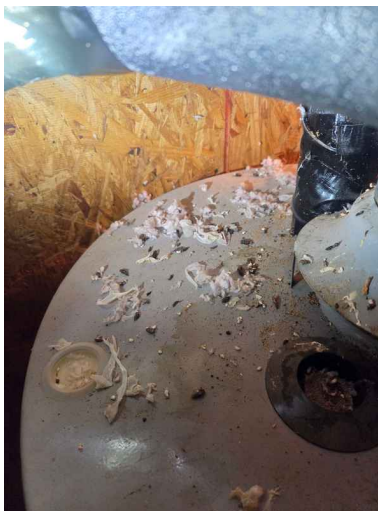
Evidence of previous pest activity was observed in the attic near the water heater during inspection. Pest activity can indicate conditions that attracted insects or rodents, such as moisture, food sources, or entry points.

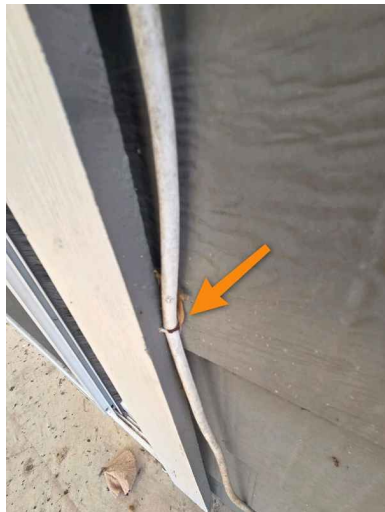
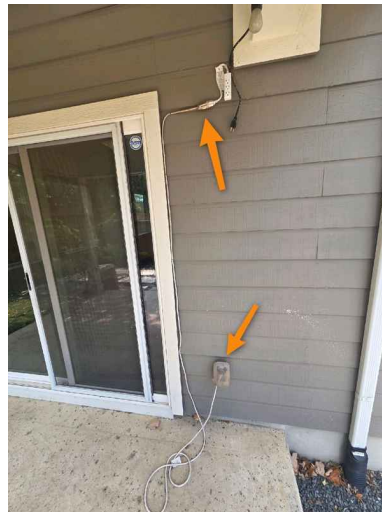
Exterior left

**3: Wiring, exposed, not enclosed in conduit**

🟡 Moderate Concern

Temporary wiring was exposed where it should have been enclosed within conduit. Corrections should be made as necessary by a qualified electrical contractor.

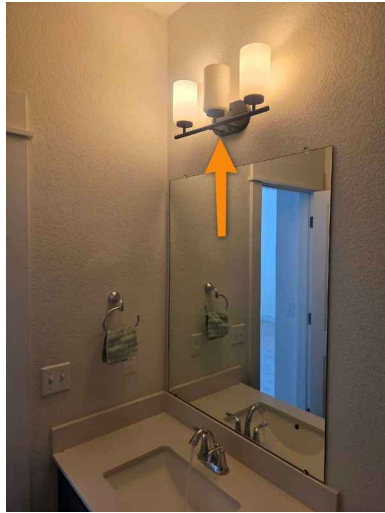
**4: Bathroom: inoperable light**

🟢 Minor Concern

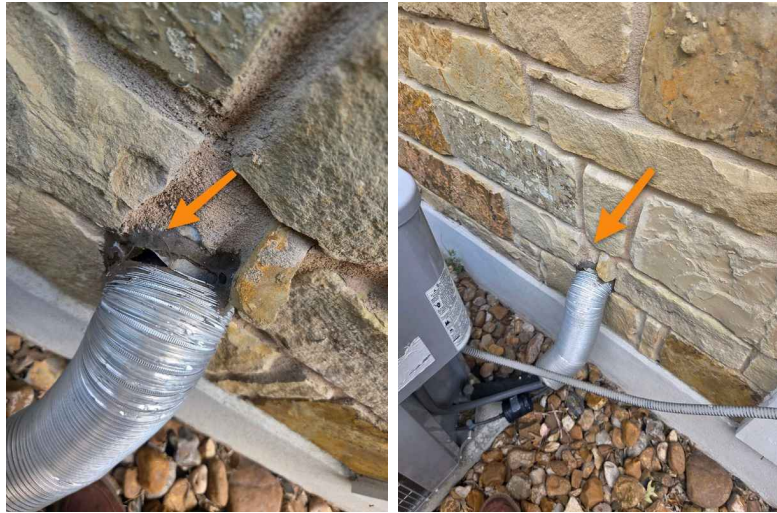
### 1: AC refrigerant Lines: seal wall penetration

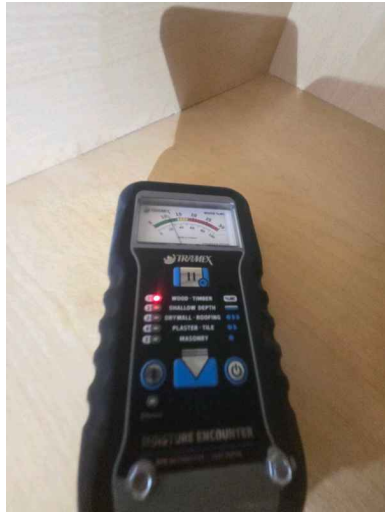
**2: Under-sink cabinet: visible moisture damage, active leak**

🟡 Moderate Concern

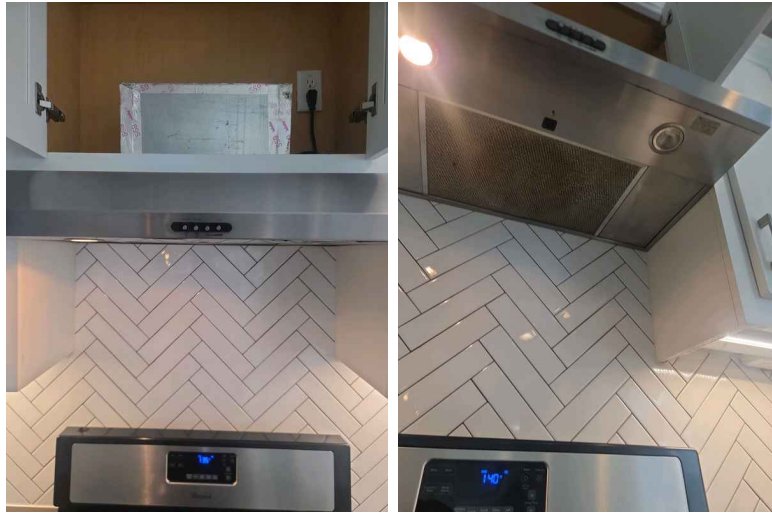
**1: Lights inoperable**

The range hood lights were inoperable. The bulb may be burned out, or there may be a problem with the switch, wiring or light fixture. If after replacing the bulb the light fixture still does not respond, the Inspector recommends service by a qualified contractor.

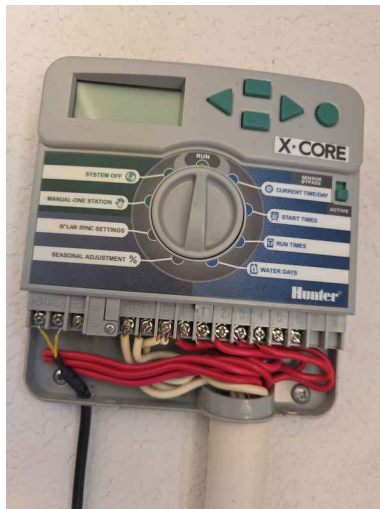
*Irrigation System Controller Inoperative:* The irrigation system controller failed to power on during inspection. Multiple outlet locations were tested with an extension cord without success, preventing evaluation of the sprinkler system's operation and components.

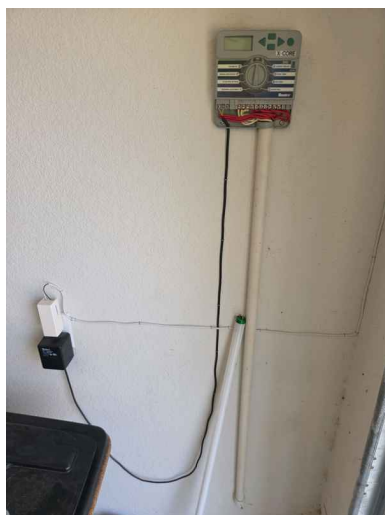
#### 1: Landscape irrigation: operation, did not respond

The landscape irrigation (sprinkler) system did not respond to the controls and should be serviced by a qualified landscape contractor.
